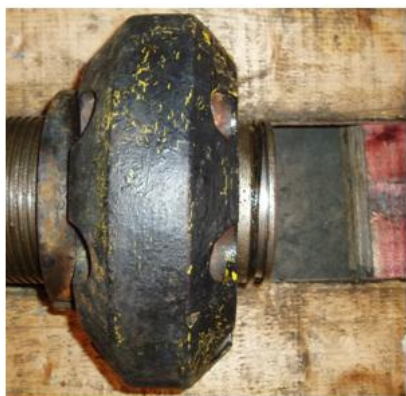
Single "o" ring in springsele groove

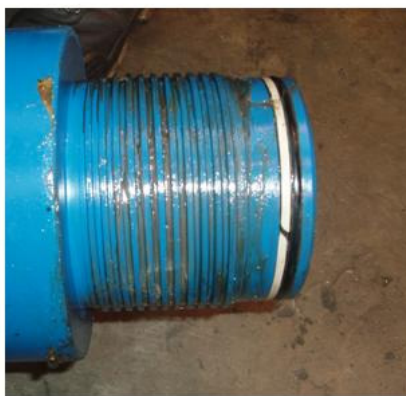
"O" ring and back up in springsele groove

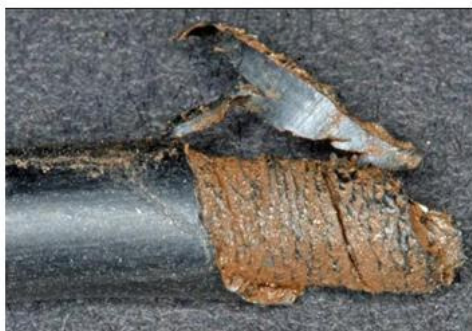
Seal damage due to inadequate support

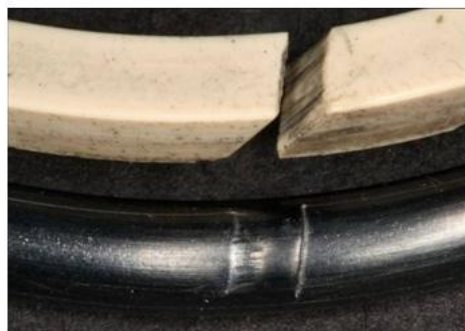
Seal damage due to inadequate support
