**SAFETY ALERT - #13 - 2009**  
**ARC FLASH INCIDENT – No Loss**  
**RELEASE DATE: SEPTEMBER 9, 2009**

<b>Function:</b> Production Facility	<b>Incident Date:</b> April 23, 2009
<b>Incident Type:</b> Non Injury	<b>Country and Region:</b> Western Canada

An arc flash occurred when a technician touched two exposed lugs of a 480-volt main breaker in a Motor Control Center (MCC) while performing commissioning checks.

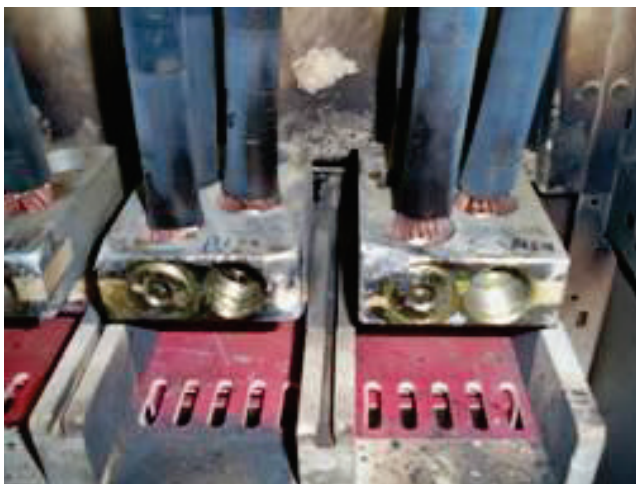
During the course of commissioning a new 480v MCC, a contract technician was required to perform phasing checks on the exposed lugs on the line side of the 480v main breaker. The technician was using a commercially available set of phase sticks with a shepherd-hook style end. When the technician attempted to check the phase C lug, the hooked end of the phase stick came in direct contact with both B and C phase lugs. Spacing between the lugs was approximately 1". As per manufacturer's specification for this voltage, there were no barriers between the lugs. The resulting contact caused an arc flash.

**Phase B and C Lugs after the incident**

- Review and enhance contractor selection process to ensure that training standards and procedures have been established for electrical contractors performing energized electrical work.
- Develop an Arc Flash Hazard Study standard consistent with industry standards. Ensure that all analysis are conducted in accordance with this standard and that the results are communicated to personnel performing maintenance work.
- Revise/enhance Company standards and training program to address arc flash and electrical shock hazards.
- Work on energized electrical equipment is a critical task and requires that a Field-Level Hazard Assessment (FLHA) be completed before beginning work.

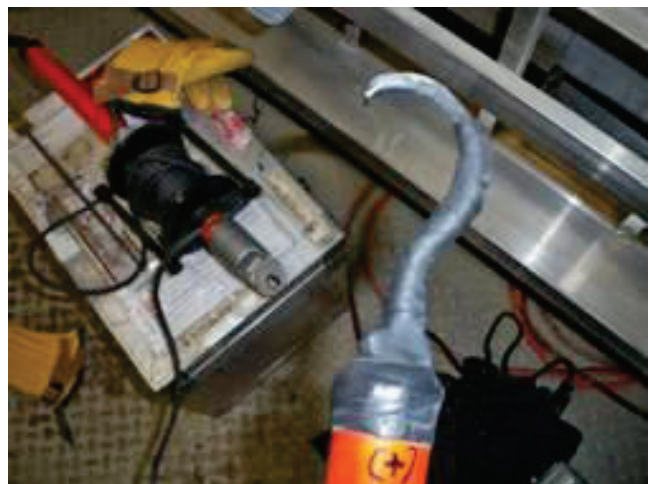
**Phase Stick Hook Used to Check MCC**

- The 'shepherds' hook style phase stick was designed for testing overhead lines and was not the appropriate equipment/tool for checking this equipment.
