## Wireline Control Valve Tips Over Onto Worker Inexperienced worker injured

SAFETY ALERT

ISSUE #: 03-2011

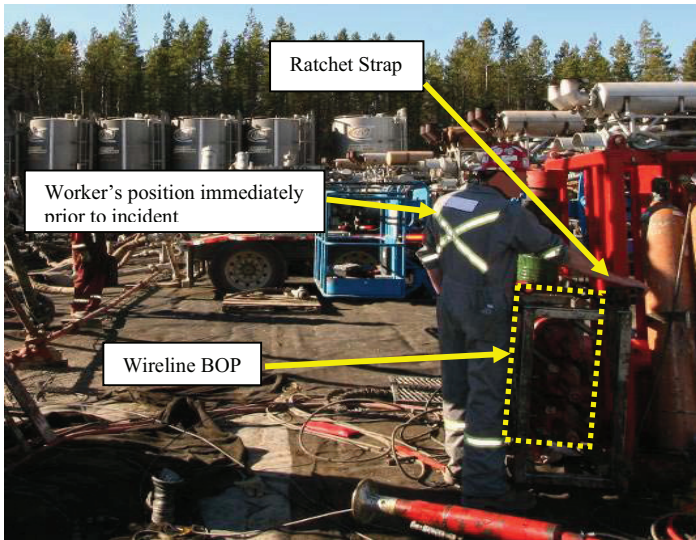
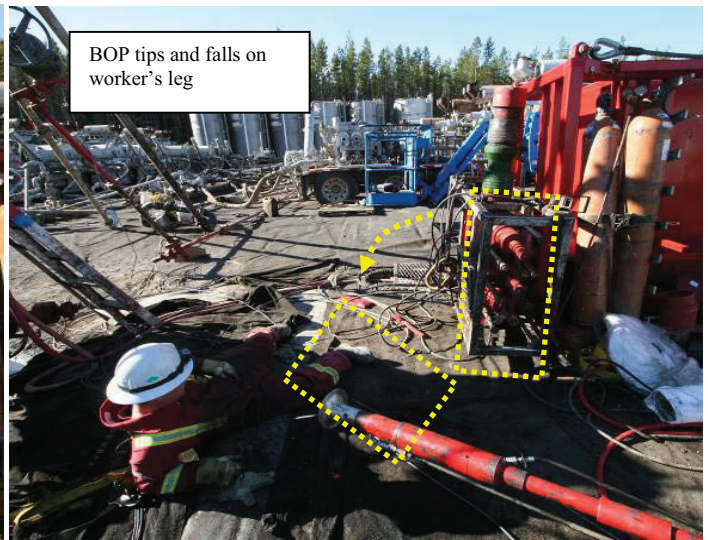
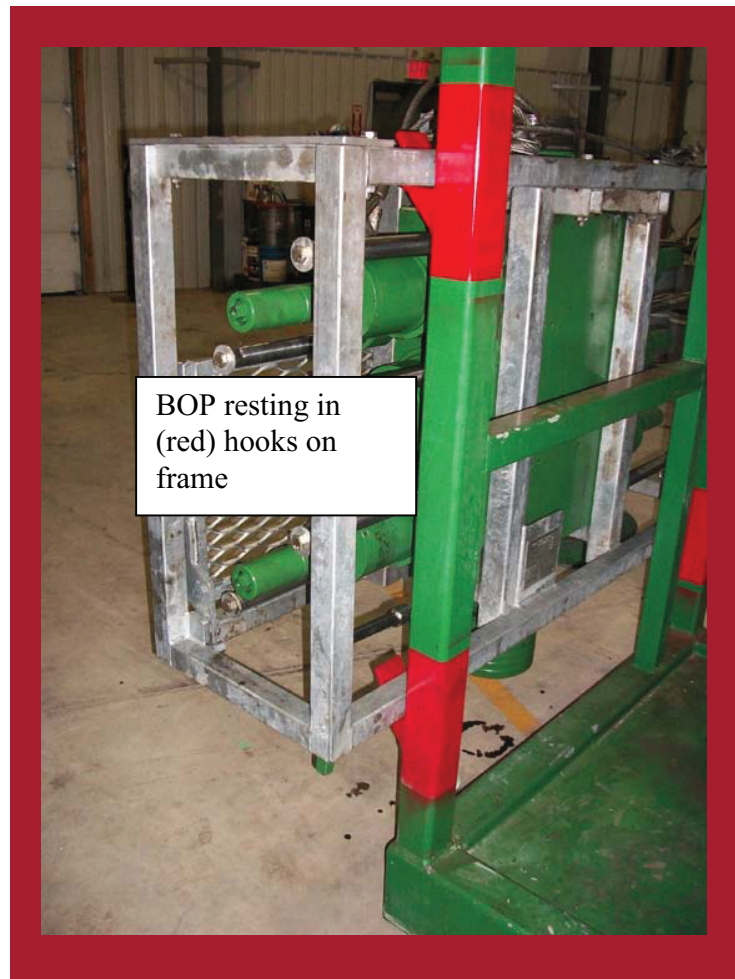
- A wireline crew was preparing to lift a wireline BOP control valve onto the well head.
- The control valve had been secured to a frame structure on the ground by means of two ratchet straps to prevent it from falling over.
- A new worker was assigned the task of hooking the valve to the crane hook by means of a lifting sling.
- The worker was seriously injured, when the wireline control valve fell over and knocked him to the ground.

- The new worker released the straps and then attempted to put the sling into the crane hook.
- The worker did not recognize the risk of putting himself in the path of a potential tip over.

Fixed hooks have since been installed on the frame structure, where the BOP is set into, when it is taken off the wellhead. This engineered solution eliminates the need to use ratchet straps to restrain the BOP while not in use.
