High Value Learning**Offshore Deluge Systems****Who could be interested in this?**

Active Fire Protection (AFP) is a critical safeguard across offshore installations, designed to protect personnel in the event of an emergency.

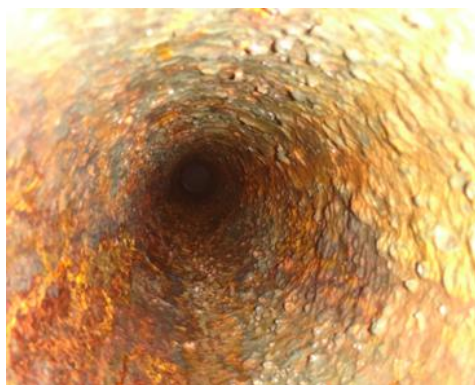
A key finding was the buildup of internal corrosion, which had led to scale detachment and, consequently, poor system performance during testing. In one instance, the absence of a chemical dosing system had also allowed marine growth to develop within the pipework, further compromising flow rates and nozzle discharge.

Internal Corrosion

Addressing the root cause is essential to ensuring deluge systems remain fully operational and capable of performing as intended during an emergency. System integrity can be enhanced by upgrading to corrosion-resistant materials, such as Elastopipe or CuNi or reviewing the use of other technological solutions. Alternatively, a comprehensive internal retro-jetting intervention of existing carbon steel pipework with appropriately located drain points can be carried out. Coupling these measures with an improved preservation and maintenance regime, including the application of a corrosion-inhibiting coating, will significantly improve system performance.

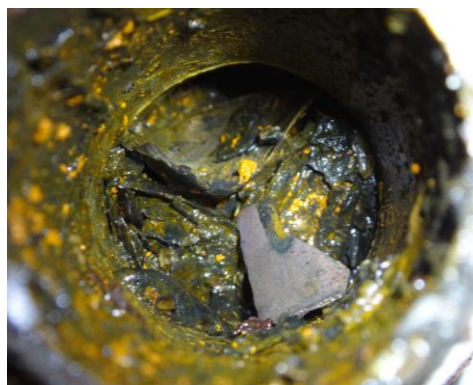
Marine Growth

Consider introducing a chemical inhibition solution post testing on carbon steel systems

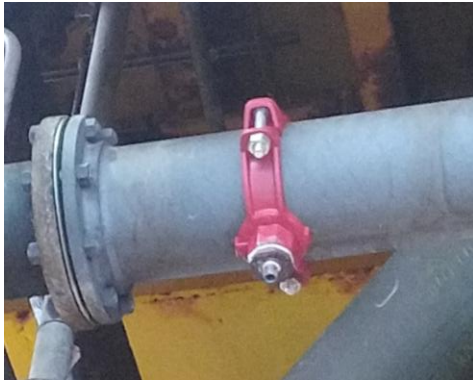
Low Point Drain

Of particular concern was the presence of deadlegs, sections of pipework where stagnant seawater can accumulate. These areas are highly susceptible to internal corrosion and biofouling, especially in systems lacking continuous chemical dosing. Such conditions significantly increase the risk of blockages forming between testing intervals.

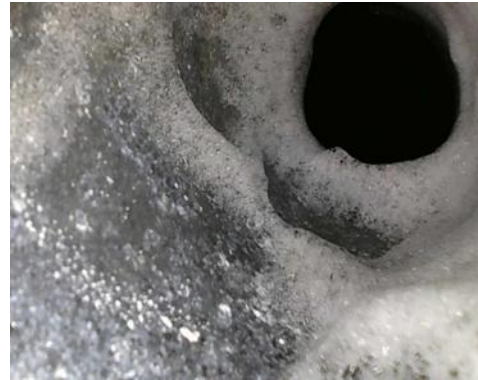
Corrosion Inhibitor Foam Application
