High Value Learning

Offshore Deluge Systems

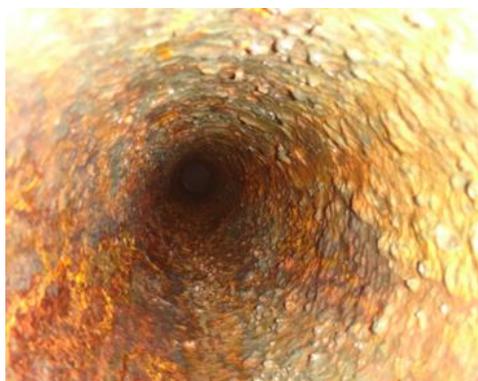
A key finding was the buildup of internal corrosion, which had led to scale detachment and, consequently, poor system performance during testing. In one instance, the absence of a chemical dosing system had also allowed marine growth to develop within the pipework, further compromising flow rates and nozzle discharge.

Internal Corrosion

To preserve the integrity and operational readiness of deluge systems, whether constructed from carbon steel or corrosion-resistant materials, it is suggested that duty holders should implement proactive strategies to prevent internal degradation.

Addressing the root cause is essential to ensuring deluge systems remain fully operational and capable of performing as intended during an emergency. System integrity can be enhanced by upgrading to corrosion-resistant materials, such as Elastopipe or CuNi or reviewing the use of other technological solutions. Alternatively, a comprehensive internal retro-jetting intervention of existing carbon steel pipework with appropriately located drain points can be carried out. Coupling these measures with an improved preservation and maintenance regime, including the application of a corrosion-inhibiting coating, will significantly improve system performance.

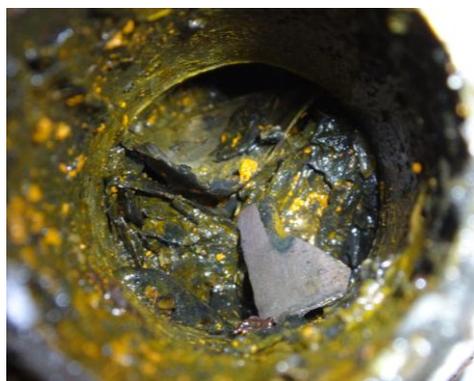
Marine Growth

Consider introducing a chemical inhibition solution post testing on carbon steel systems

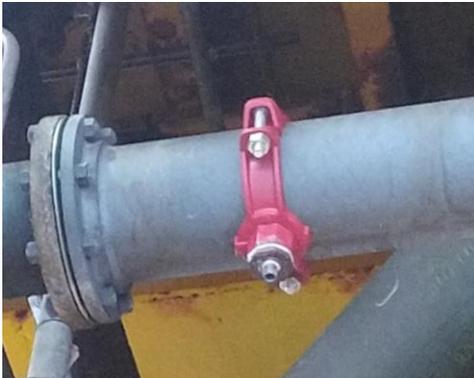
Low Point Drain

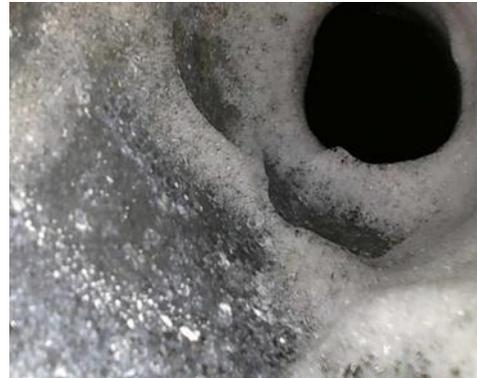
Corrosion Inhibitor Foam Application
