# Rust Particle Enters Eye During Spool Removal

**SAFETY ALERT**

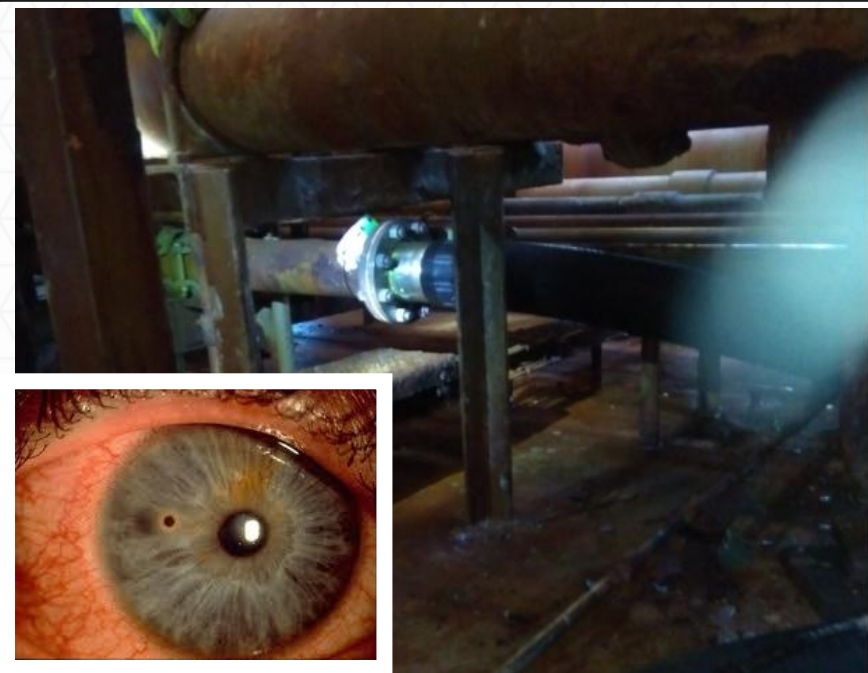
A Mechanical Tech was tasked with the removal of a spool. Due to the location of the spool, the technician had to work in a restricted space, lying on their back to access the flange bolts. During removal, the IP felt what they believed to be rust, hit their face. Following this, the IP re-positioned themselves, at which point they felt the foreign object in their left eye. The IP was able to finish the task but, when walking back to the accommodation, experienced further eye irritation and identified that the foreign body remained in their eye.

- Risk Assessment highlighted the potential danger of the worksite by recognising that “use of goggles should be considered”.
- Work Party assessed the space and manner of working and decided that goggles would restrict vision and be likely to steam up.
- The IP was wearing safety glasses which were not suitable for the task or a close fit to the face.
- The job was not stopped despite indications that there was a problem.
- Insufficient Dynamic Risk Assessment and selection of PPE.

- Where a hazard has been identified, controls should be clearly identified and instructed.
- Personnel to be aware of the range of eye protection (Glasses, Spoggles, Goggles and face shields) and use the most appropriate protection for the task.
- Where there is a Dynamic Risk Assessment section in the TBT, this should be completed to detail work party discussions.
