Safety Alert

Number: 25-08

Subject: Grease Gun Hand Injury

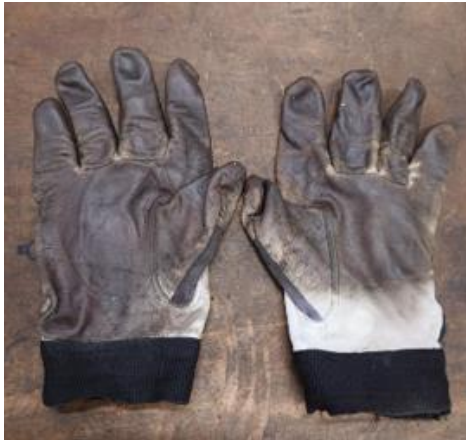
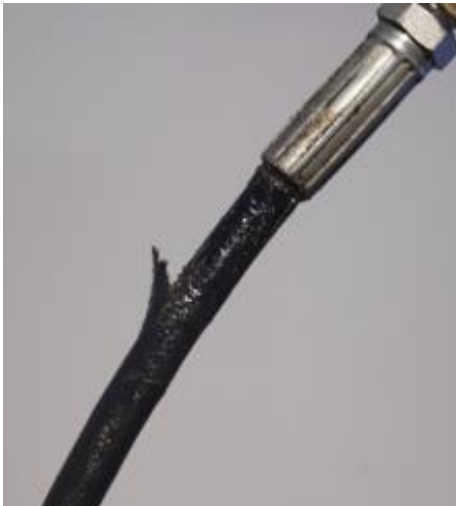
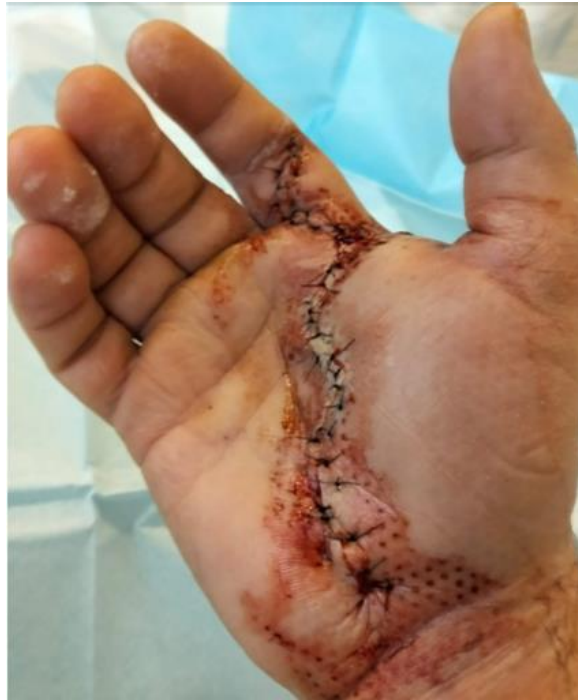
Photographs / Supporting Information

As the crew member attempted to remove the greasing hose from the greasing point, the hose burst on his right hand.

The high-pressured grease passed through the damaged hose causing a penetration through his glove, leading to a small open wound on his skin.

- The failure of the greasing gun hose under pressure caused the unexpected release of grease.
- The pressure release valve did not function as expected, causing grease to be injected at high pressure.

- Specific JSA / RA to be in place for using grease guns and compliance with equipment manufacturers manual. Anyone using grease guns should inspect the integrity and security of grease nipples and hoses prior to starting the task.
- Ensure correct gloves are used with grease gun (part of JSA).
- Raise awareness on dangers of using grease guns throughout company and at wider industry level.
- Investigate suitable alternatives to the grease guns in use.
- Discuss incident with OEM to inform them about the hose failure.
