Shelter NFI Rapid Assessment

West Guji and Gedo

May 2019

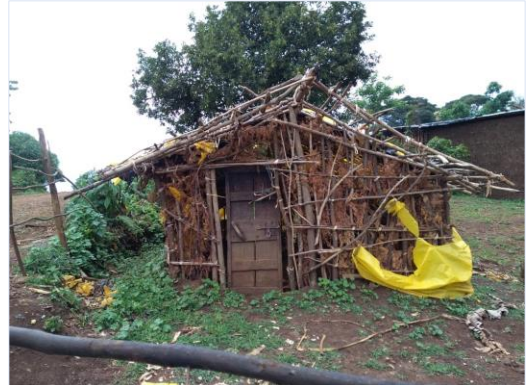
Figure 1: Example of self constructed shelter (2) in Gelana by GOAL.

Those who have returned are **sheltering outside (1)** or constructed **substandard shelters (2)** with poor protection from the weather conditions. The werdas with high number of houses damaged are Kercha, Gedeb, Hambela, Abaya and Yirgachefe. Considering the number of previous returnees in this werdas, it's feasible to start shelter reconstruction programs as a first phase of the response.

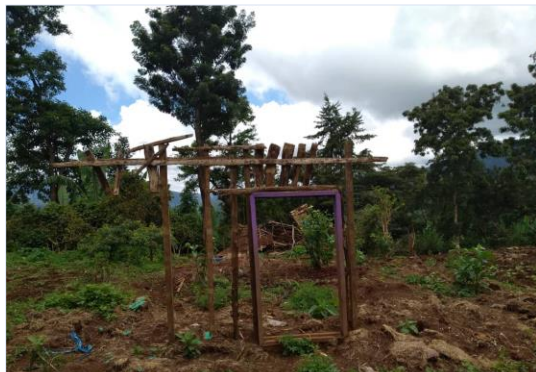
Figure 2 Example of damaged shelter in Eda Farfa (Kercha) by GOAL.

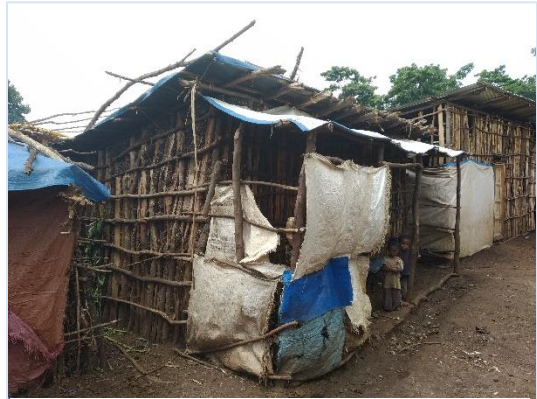
Figure 3 Shelters in Chirico (7) returnee site (Yergachefe) by Shelter

Those IDPs that are living in collective sites (5) or within the host community (6) required a more in depth need assessment to understand if they are willing to resettle and require support to pay rents, or if they need ES/NFIs to return to their land. Returnees in collective sites (7) in Chirico have receive assistance previously, but their living conditions are inadequate, cash for NFIs is advisable.
