# Asbestos in Emergencies:

## *Safer Handling and Breaking the Cycle*

This booklet is a simple and practical guide for transitional settlement and reconstruction practitioners. It aims to provide basic background information on asbestos and its associated health risks. It provides key recommendations for minimising the risks of dealing with asbestos in post-disaster transitional settlement and reconstruction operations and suggests further reading sources for more in-depth technical information.

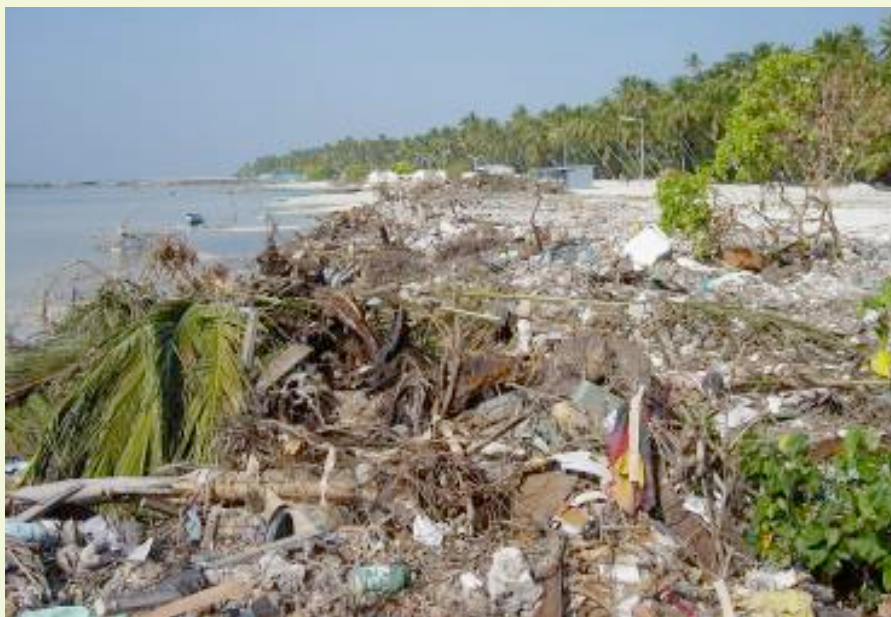
Tsunami-damaged asbestos-cement roofing sheets and ceiling boards were identified. Clean-up teams were not removing or separating damaged pieces of asbestos-cement from building rubble. Some roof sheets had been salvaged and stacked for re-use while others had been manually crushed into small fragments. In some cases, attempts had been made to burn it.

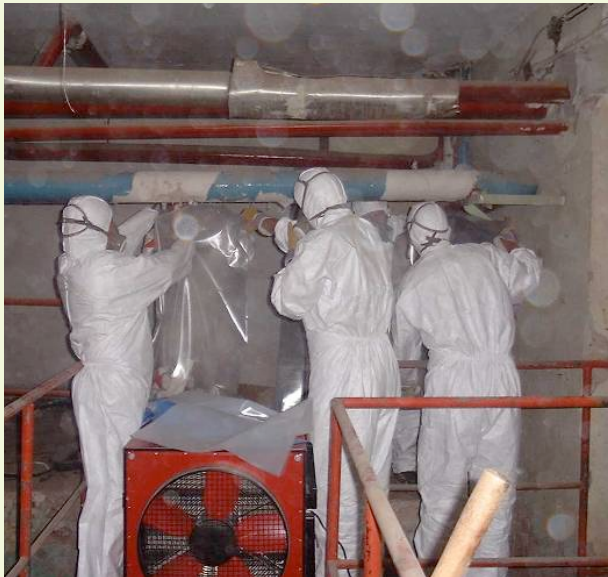
- six Kosovar asbestos operatives trained specifically in asbestos removal;
- the necessary Personal Protective Equipment for use in asbestos removal;
- the necessary asbestos removal equipment such as containers, a generator powered air pump for creating negative air pressure in the sealed working area, as well as tenting material to create a safe working area; and
- a specially designed welfare container with showers and decontamination zone for the personnel to use on-site.

The asbestos removal team supported various international NGOs, the UN and local authorities in the safe removal of the asbestos which was then disposed of at designated landfill cells in Kosovo.

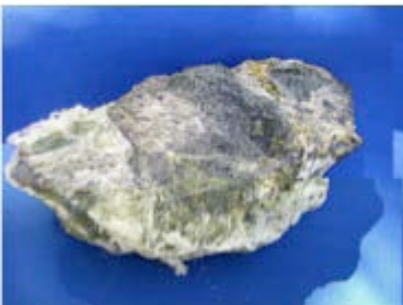
Chrysotile asbestos

- **Chrysotile** (white asbestos) has a very good resistance to alkalis. It is the most common type of asbestos, accounting for over 90 per cent of asbestos mined annually. It is most frequently found in asbestos-cement products such as roofing sheets.
- **Amosite** (brown asbestos) has a very good resistance to high temperature and is used in thermal insulation products and ceiling tiles.

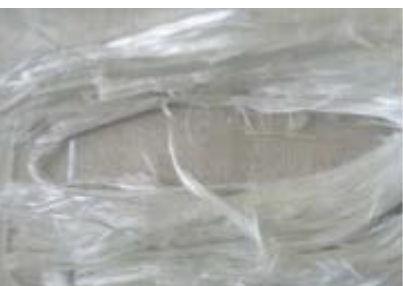
Asbestos fibres

Friable asbestos presents very serious health risks as asbestos fibres are loose and easily released into the air. Breathing these fibres causes serious lung diseases. Loose fibres are so small that they are not normally visible and are not stopped by dust masks alone.

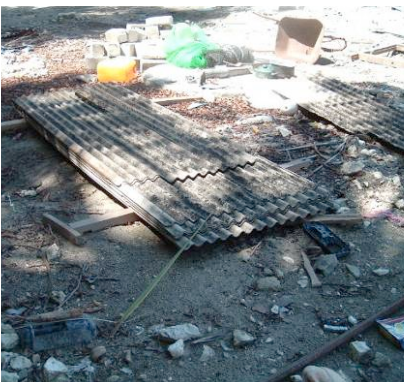
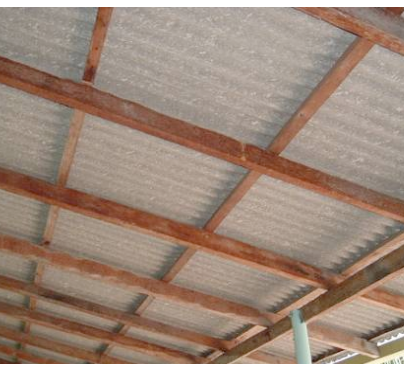
“ *Corrugated asbestos-cement roof sheets are still commonly used and widely available for sale in developing countries.* ”

The handling and disposal of corrugated asbestos-cement roofing sheets can release asbestos fibres and thus presents a health hazard. Their use should be avoided in new construction. Alternative materials should be investigated and used. Where existing roofing sheets are damaged, only handle and dispose of them with a specialist and properly equipped and trained team.

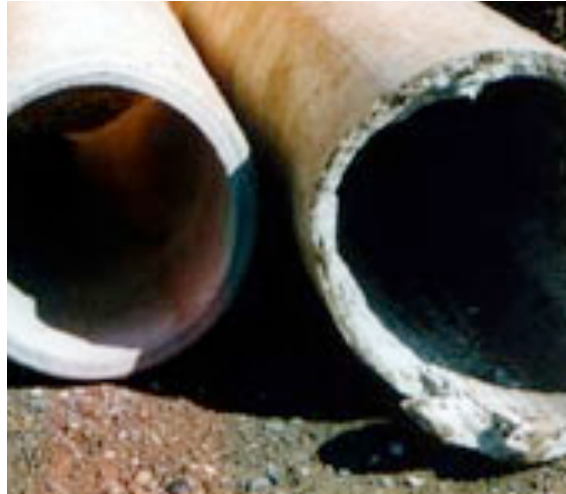
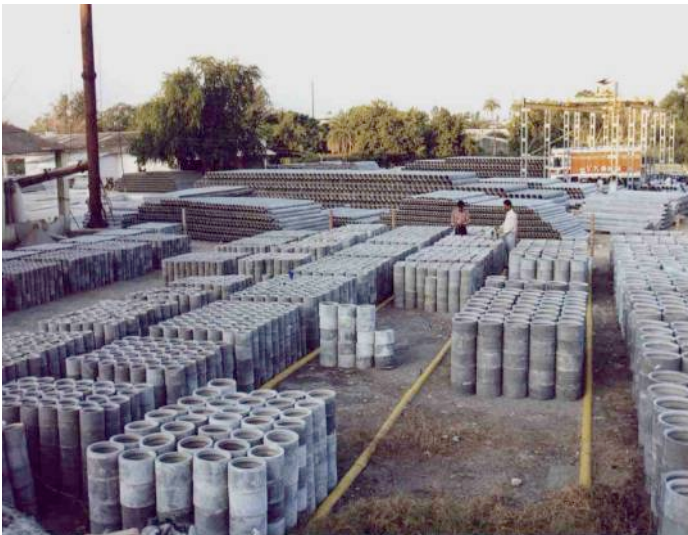
Asbestos-cement pipes have been widely used for drinking water distribution. Today, however, few countries still install asbestos-cement pipes.

From numerous studies, there appears to be no concern for the health of consumers receiving water and no programmes exist to specifically replace asbestos-cement pipes for this reason. However, should the pipes become damaged with time, or during a natural disaster, their handling, disposal or replacement could release asbestos fibres and cause health risks.

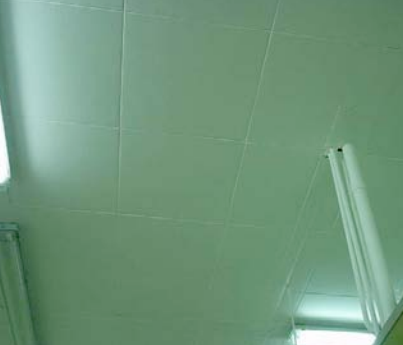
## **Asbestos Ceilings and Floors**

Asbestos insulating boards have typically been used for ceiling boards and false walls. Asbestos vinyl floor tiles are also common. Bituminous tar paste was widely used to glue down linoleum tiles, particularly in commercial buildings and hospitals built in the 1970s.

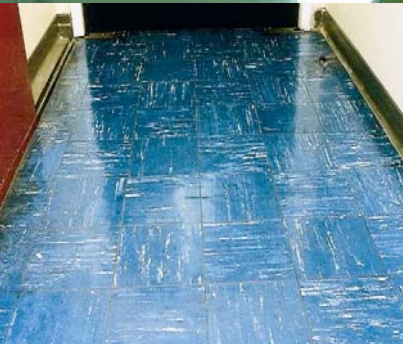
## **Asbestos Fire and Sound Insulation**

Asbestos has been sprayed in buildings for sound-proofing and fire-proofing in developed countries. In the late 1950s, it became virtually standard practice for large buildings, hospitals and schools to have sprayed asbestos on steel columns, beams and roofing sheets. This form of asbestos is highly friable and highly dangerous if damaged or in poor condition, and has a high asbestos content of around 85 per cent.

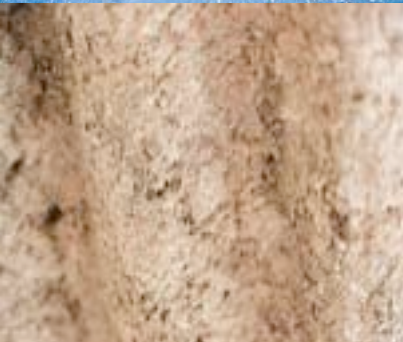
## **Asbestos Thermal Insulation**

Since the 1950s asbestos insulation was commonly used for insulating boilers, hot water tanks and hot water and steam pipes. It can be sprayed or used as loose fibres, also known as fluff form. It can also be used as a cloth wrap for other non-asbestos insulating products. Insulation of this type is highly friable and dangerous and can contain over 90 per cent asbestos.

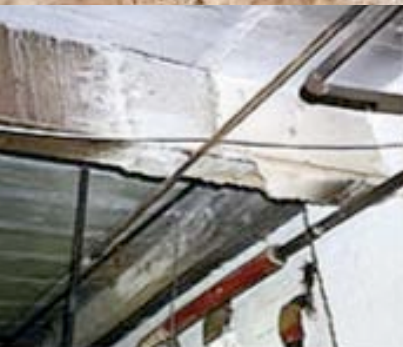
## Asbestos Artex

Asbestos containing artex was used widely as a coating in residential and office blocks, schools, hospitals and nursing homes in Europe.

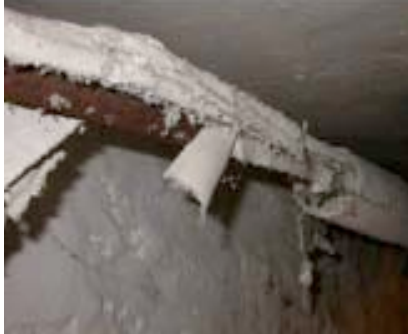
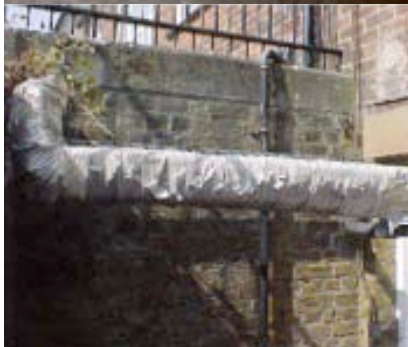
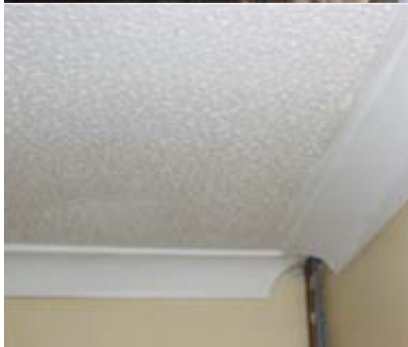
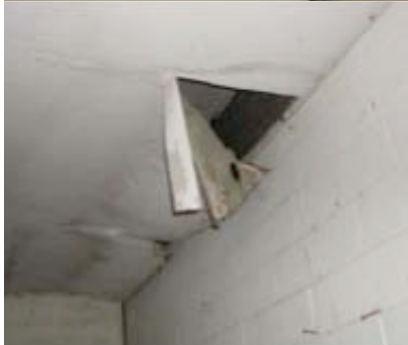
Other common asbestos-containing materials (ACMs) include:

- bitumen-bound asbestos material in roofing felt;
- thermal insulation on pipes, boilers, furnaces, ducts and as a cloth type material in gaskets;
- acoustic insulation in false ceilings and walls, especially in schools, hospitals, residential tower blocks and public areas;
- heat resistant textiles – cloth, padding, pipe wrap, fire blankets, fireproof clothing, oven gloves, safety curtains and blankets; and
- electrical switchboards, insulators and fittings; and asbestos reinforced plastics, toilet cisterns, baths, and car battery cases.

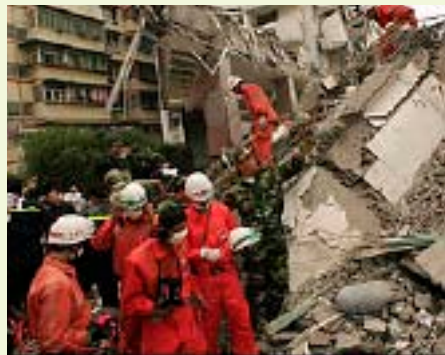
On 12 May 2008, an earthquake in Sichuan, China, destroyed many buildings including hospitals, schools, government offices and private homes. The external walls, roofs, window awnings and bathrooms in many of these buildings had been made using asbestos-cement sheets – commonly known as “fibro” or “fibro cement”. The earthquake broke the fibro into many small pieces, releasing fine fibres of asbestos at the broken edges.

During clean-up operations, there is the risk of liberating substantial quantities of asbestos fibres, particularly if heavy plants and equipment are used to demolish damaged structures and load rubble into vehicles. These asbestos fibres were a significant risk to public health.

The WHO and UNEP provided a guideline on how to control the risk of the clean-up and to safely dispose of asbestos waste in the areas affected by the earthquake.
