STUDY ON CYCLONE RESISTANT HOUSING

**COMMUNITY BASED DISASTER PREPAREDNESS PROGRAMME
BANGLADESH RED CRESCENT SOCIETY/GERMAN RED CROSS**

Author
Bashirul Haq
Principal Architect
Bashirul Haq and Associates Ltd.

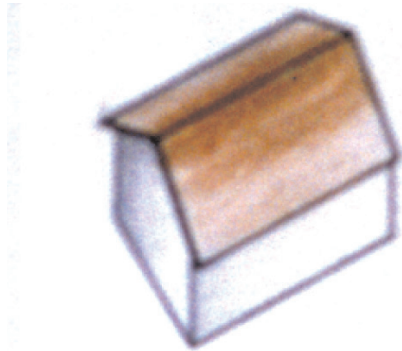
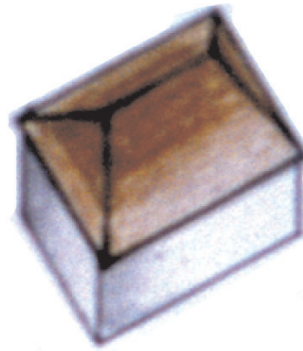
3.1.2.4 PEOPLE'S PERCEPTION OF THE MAGNITUDE OF WIND LOADING AND WIND DAMAGE ON DIFFERENT ROOF SHAPES

High Gable Roof	
Wind Resistant	Suffer Wind Damage

Hip Roof	
Wind Resistant	Suffer Wind Damage

COMMENTS: Response uniformly was for hip roof, indicating their collective experience that less damaged is caused by cyclone to hip roof.

Uniform agreement of the respondents was for hip roof, indicating their collective experience that less damage is caused by cyclone to hip roof than to high gable roofs.

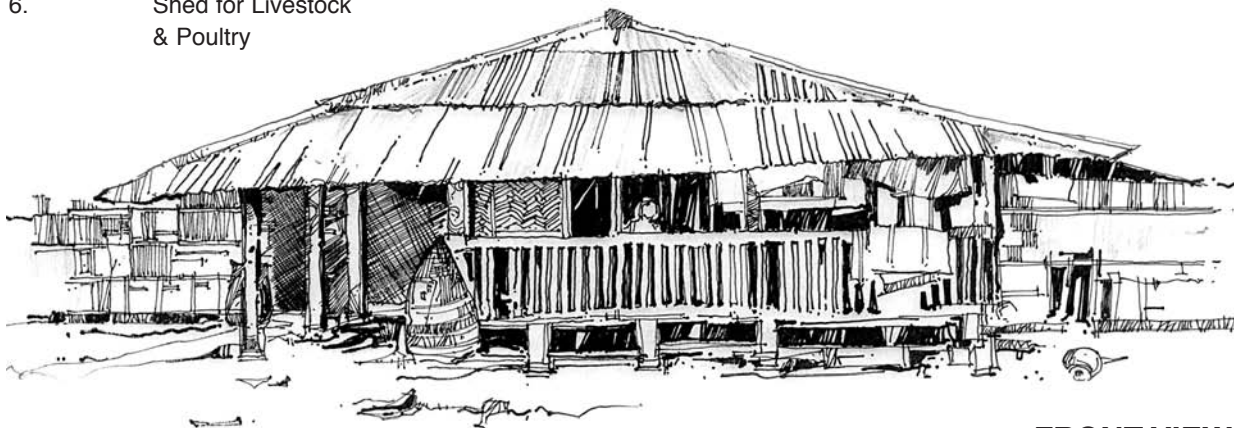
FRONT VIEW

Components	Materials
Vertical Support	: Wood Pillar & Mud Wall
Roof Support & Roofing Material	: Wooden Joist, Purlin & Tin Roof
Wall	: Bamboo, Wood & Mud Wall
Floor	: Wood Plank & Mud Finish

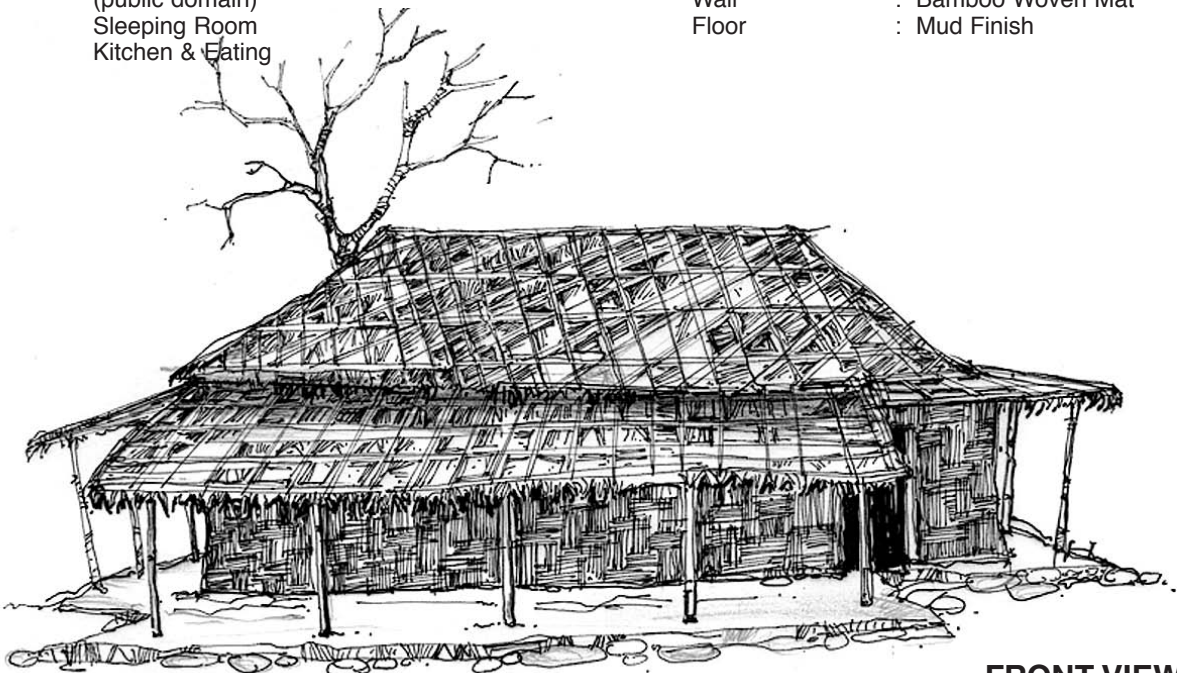
FRONT VIEW

Components	Materials
Vertical Support	: Bamboo Post
Roof Support & Roofing Material	: Bamboo Joist, Purlin & Thatch Roof
Wall	: Bamboo Woven Mat
Floor	: Mud Finish

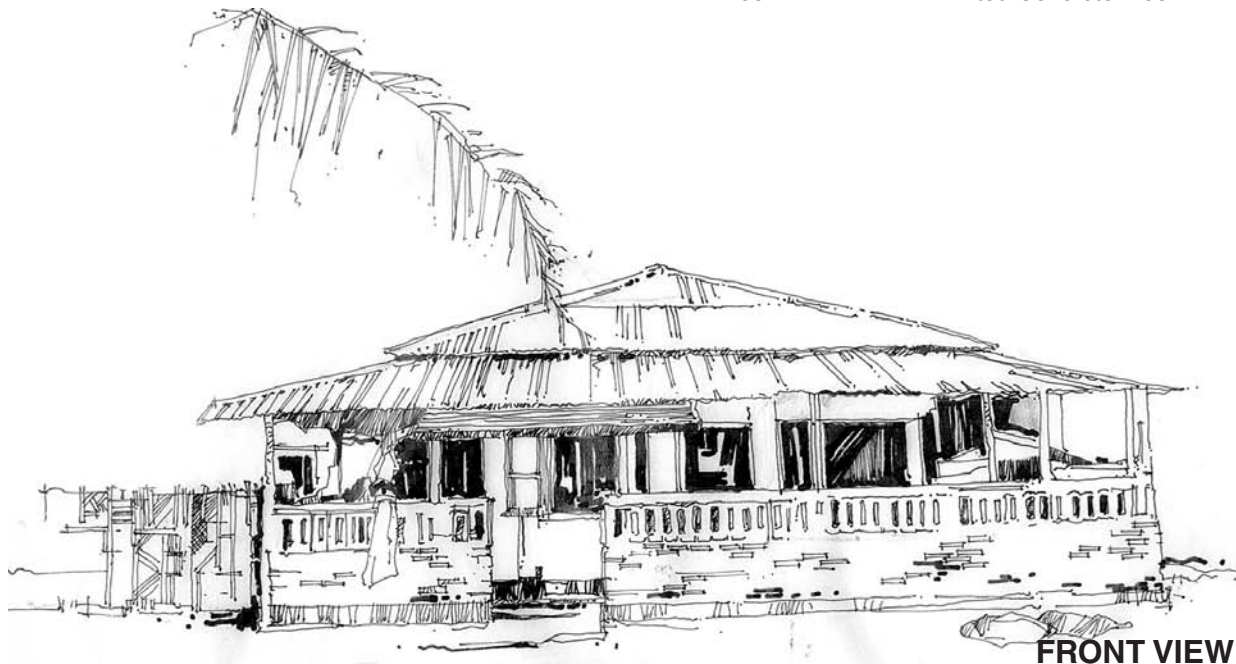
FRONT VIEW

Structure	
Components	Materials
Vertical Support	: Wood Pillar & Brick Wall
Roof Support & Roofing Material	: Wooden Joist, Purlin & Tin Roof
Wall	: Brick Wall, Plaster & Paint
Floor	: Tinted Concrete Floor

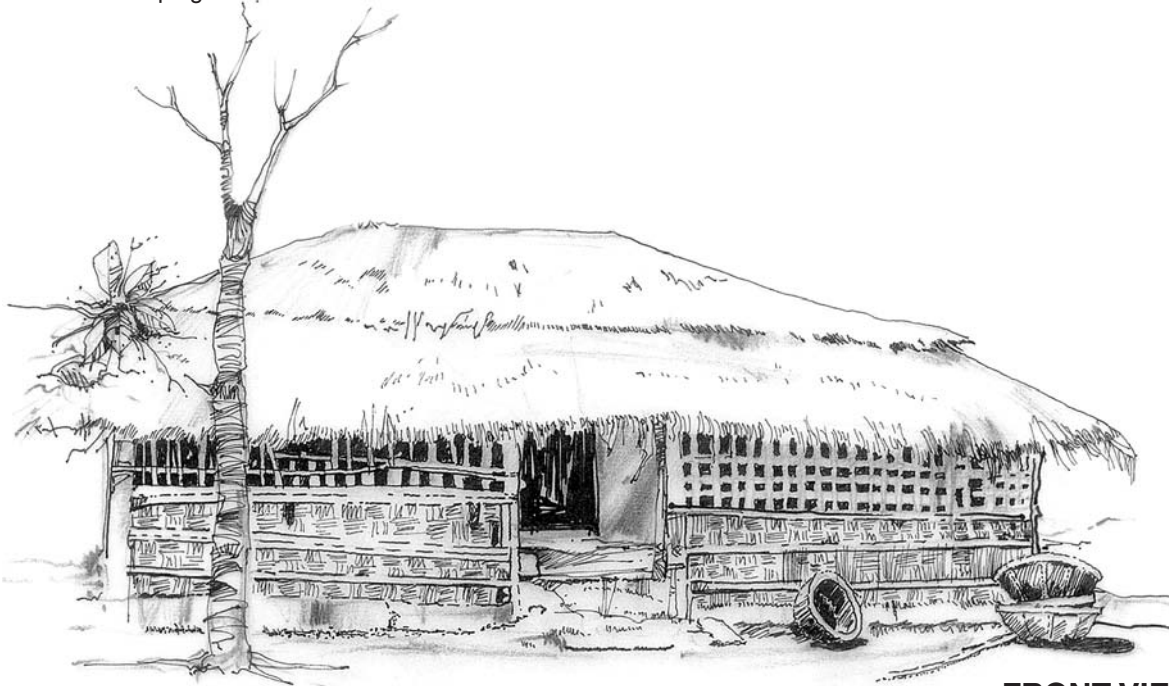
FRONT VIEW

Components	Materials
Vertical Support	: Bamboo Post
Roof Support & Roofing Material	: Bamboo Joist, Purlin & Thatch Roof
Wall	: Bamboo Woven Mat
Floor	: Mud Finish

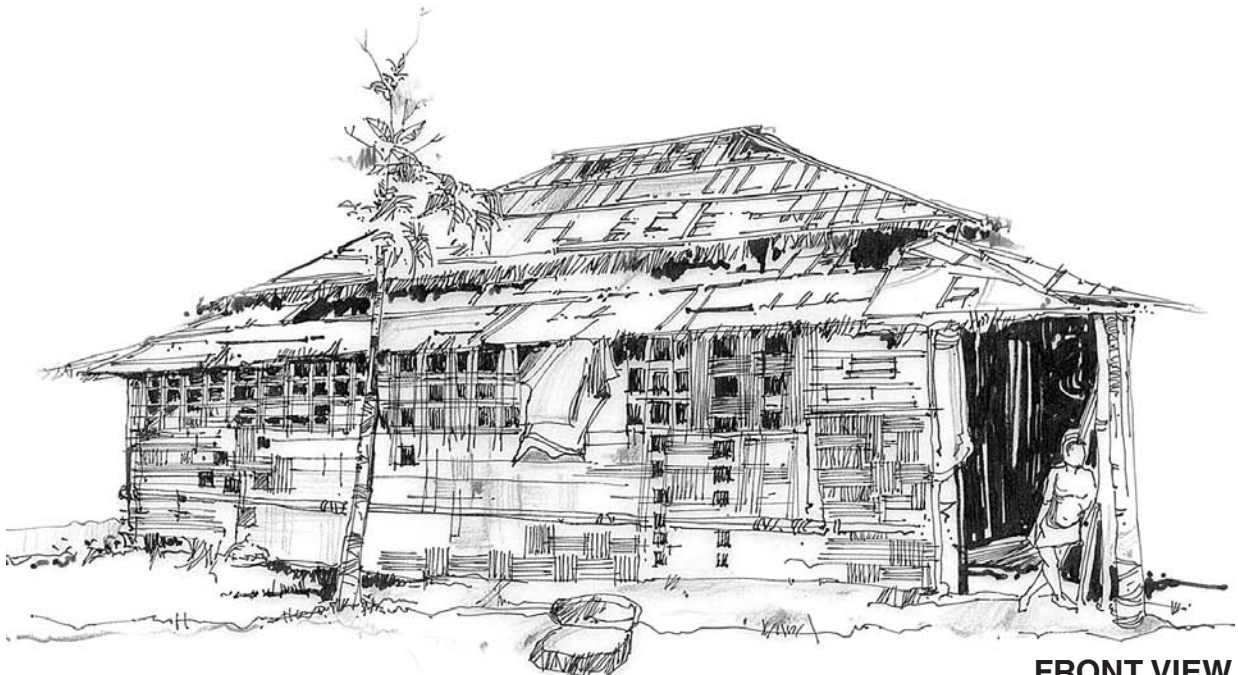
FRONT VIEW

Components	Materials
Vertical Support	: Bamboo Post
Roof Support & Roofing Material	: Bamboo Joist, Purlin & Thatch Roof
Wall	: Bamboo Woven Mat
Floor	: Mud Finish

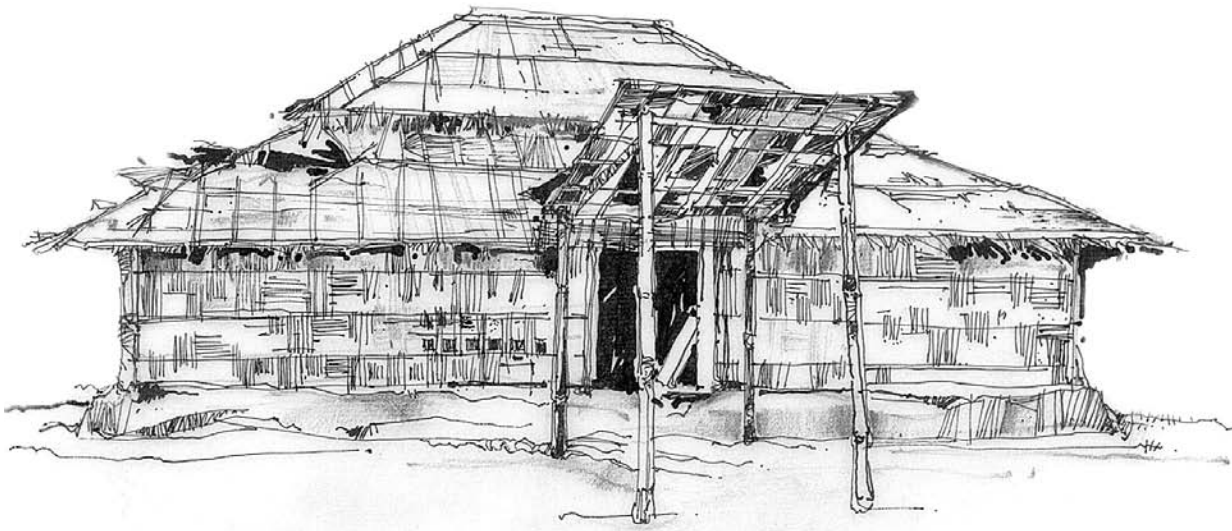
FRONT VIEW

Components	Materials
Vertical Support	: Bamboo Post
Roof Support & Roofing Material	: Bamboo Joist, Purlin & Thatch Roof
Wall	: Bamboo Woven Mat
Floor	: Mud Finish

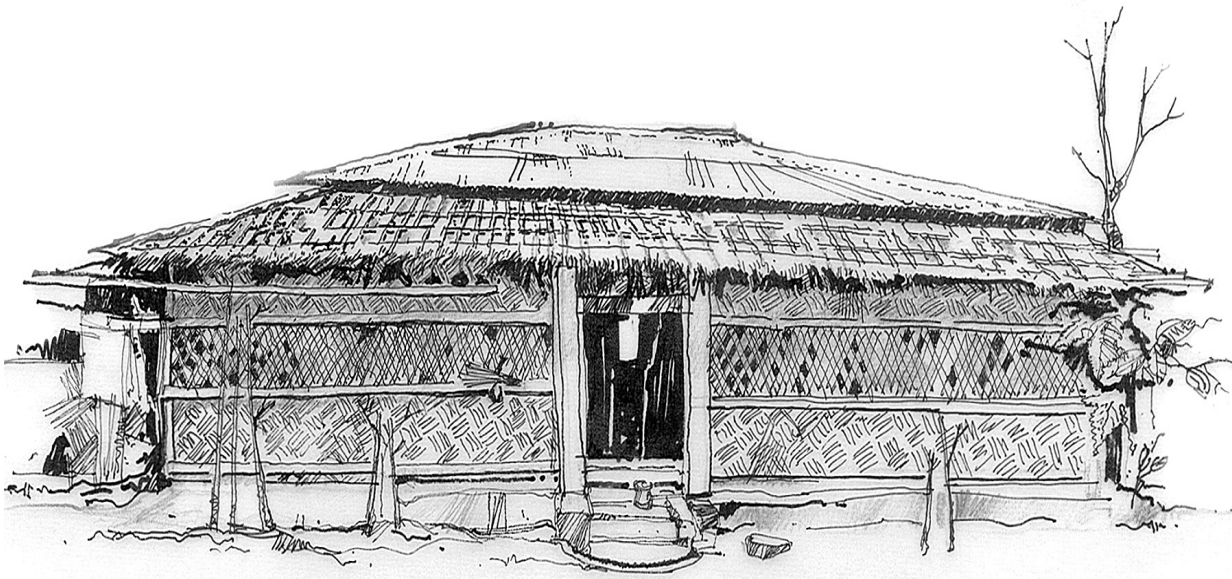
FRONT VIEW

Components	Materials
Vertical Support	: Wooden Post
Roof Support & Roofing Material	: Wooden Joist, Purlin & Tin Roof Over Ghar & Thatch Roof Over Pashchati
Wall	: Well Crafted Bamboo Woven Mat
Floor	: Mud Finish

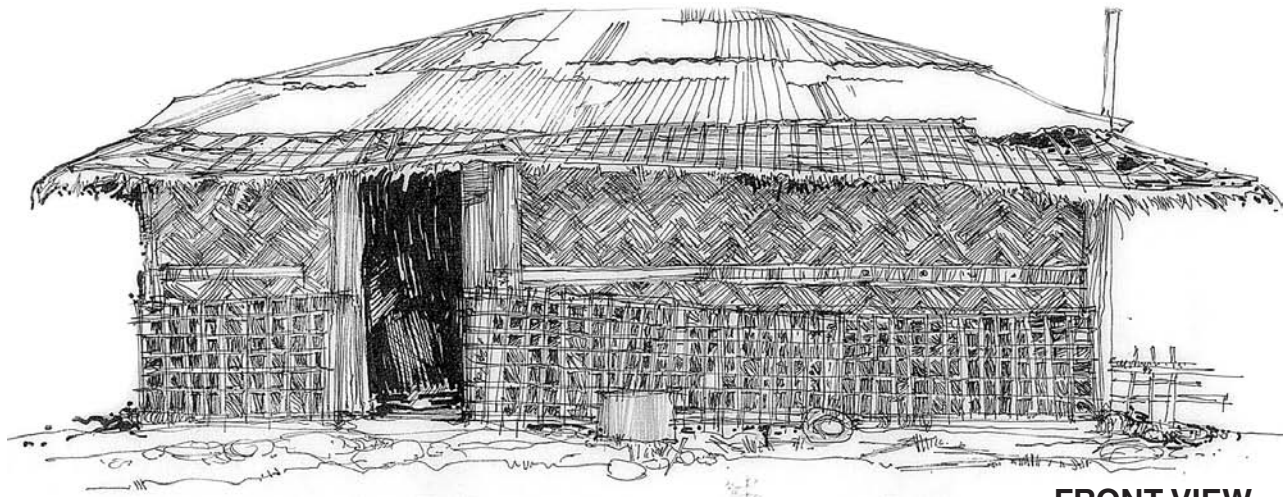
FRONT VIEW

Components	Materials
Vertical Support	: Wooden Post
Roof Support & Roofing Material	: Wooden Joist, Purlin & Tin Roof
Wall	: Bamboo Woven Mat
Floor	: Mud Finish

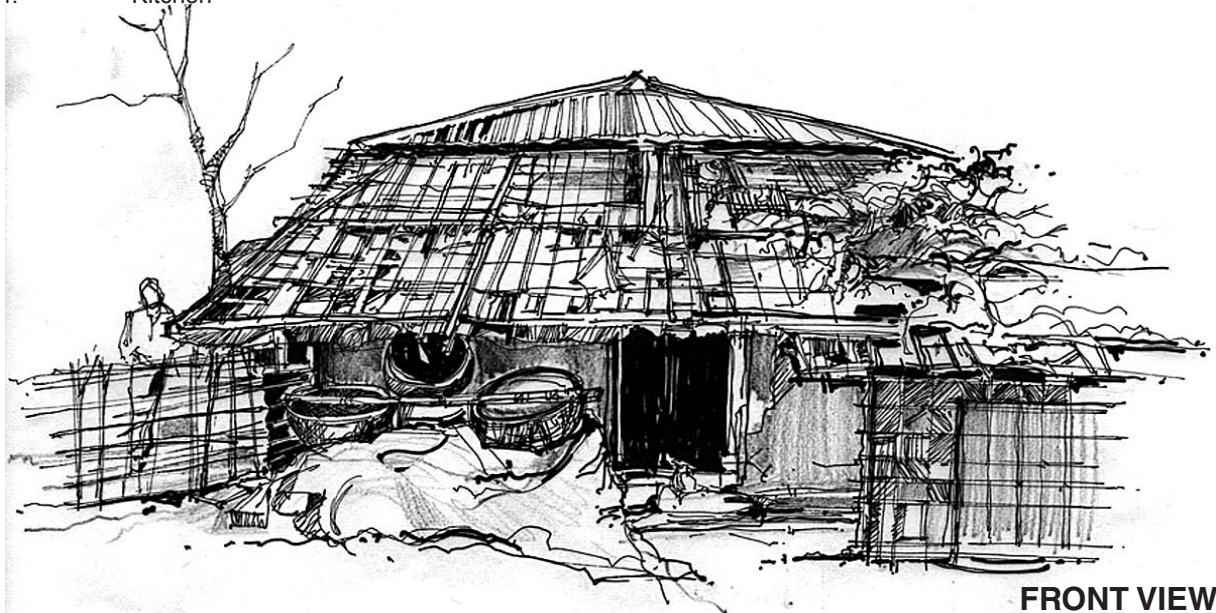
FRONT VIEW

- Vertical Support : Bamboo Post & Mud Wall
- Roof Support & : Bamboo / Wooden Joist & Purlin
- Roofing Material : Thatch / Tin Roof
- Wall : Mud Wall
- Floor : Mud Finish

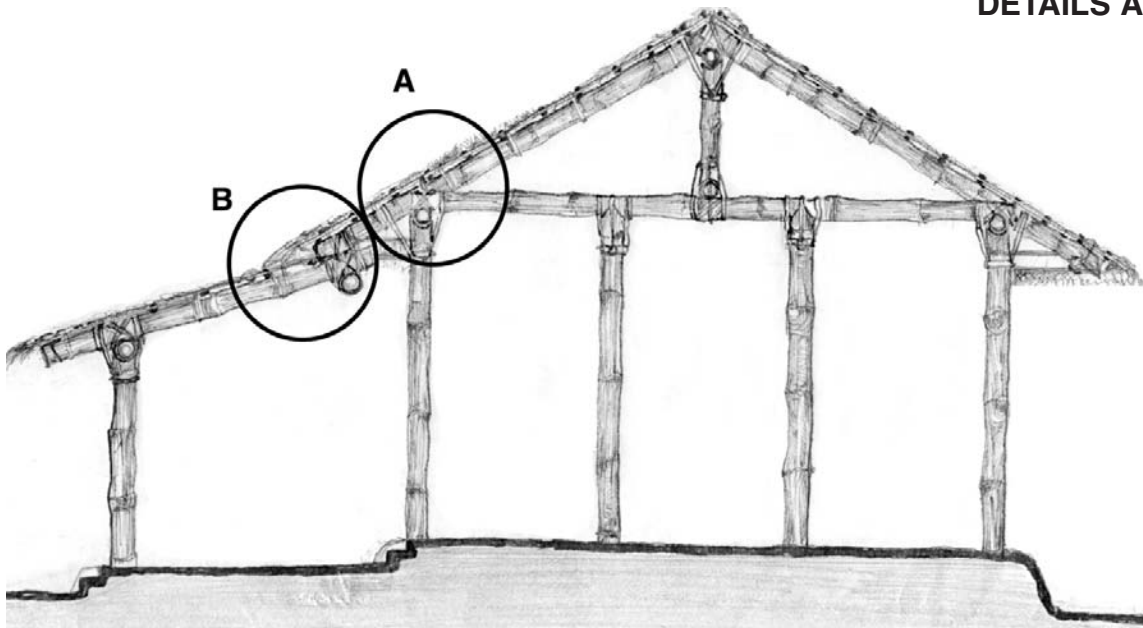
TRANSVERSE SECTION (section & details are not in scale)

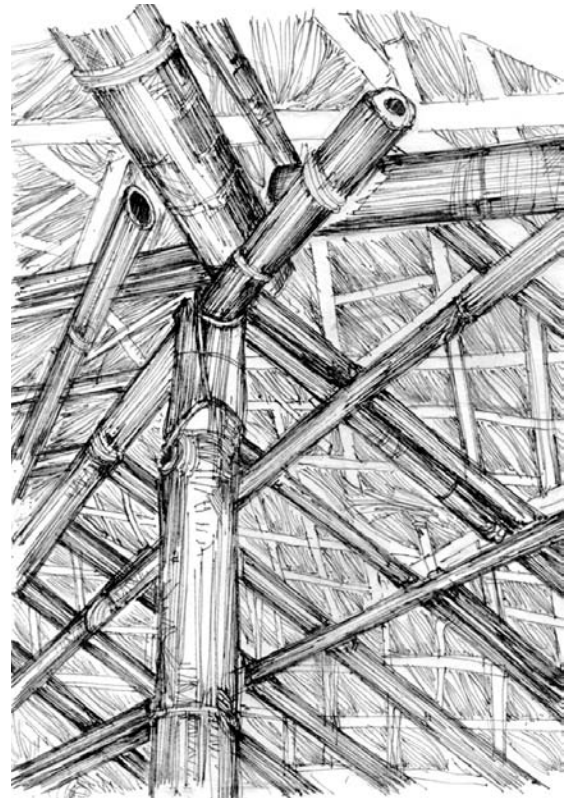
CORNER DETAILS OF RIDGE

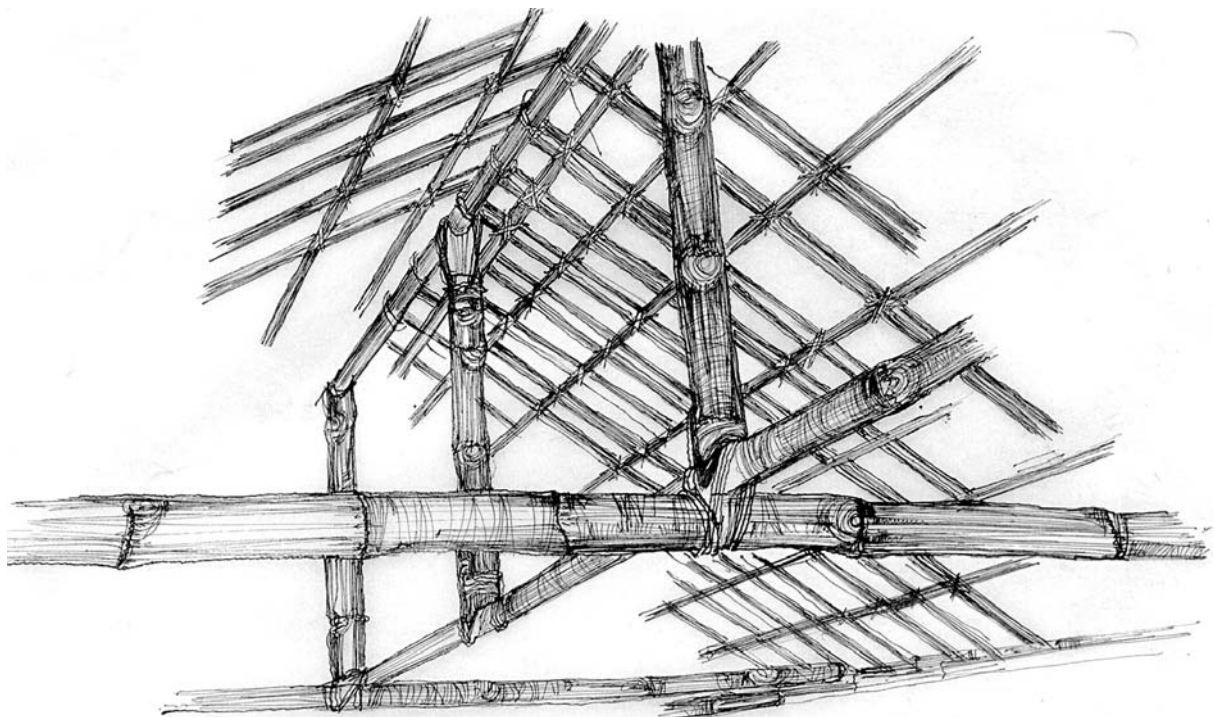
DETAIL PERSPECTIVE OF ROOF STRUCTURE

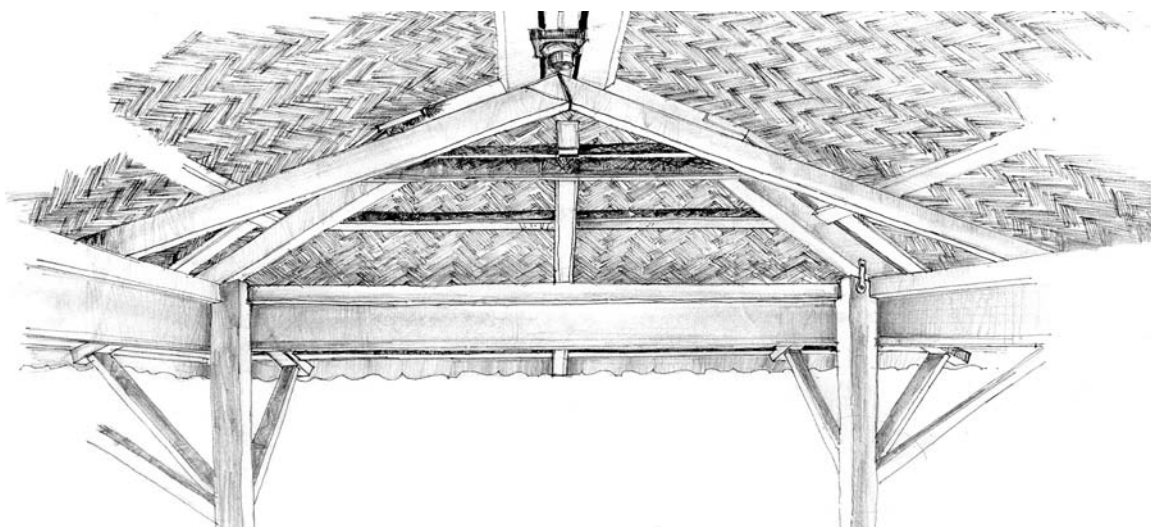
DETAILS OF ROOF AT ENTRANCE

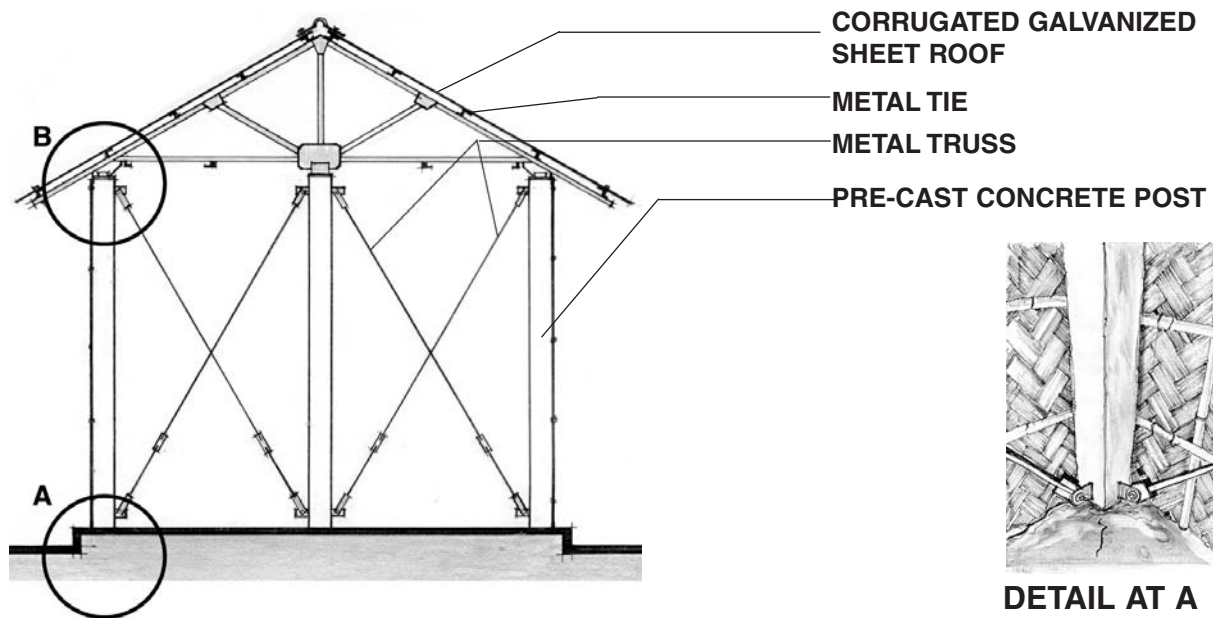
TRANSVERSE SECTION

The structure of this house type has pre-cast concrete columns for vertical support, steel truss for roof support and steel rod for bracing between columns, Bamboo mat is used as wall. The problem with this house type is not with the details of anchoring to foundation and jointing details of truss to vertical post, but the use of steel sections for fabrication of truss, roof shape and most importantly the lukewarm response and low acceptance by the beneficiaries.

Experiments have shown that houses with hip roofs have the best record of resistance to wind loads. The recommended gable roof in cyclone affected areas is High Gable roof with pitch between 35° to 45° . The roof shape of the BDRCS house type is gable roof with 27.5° pitch.

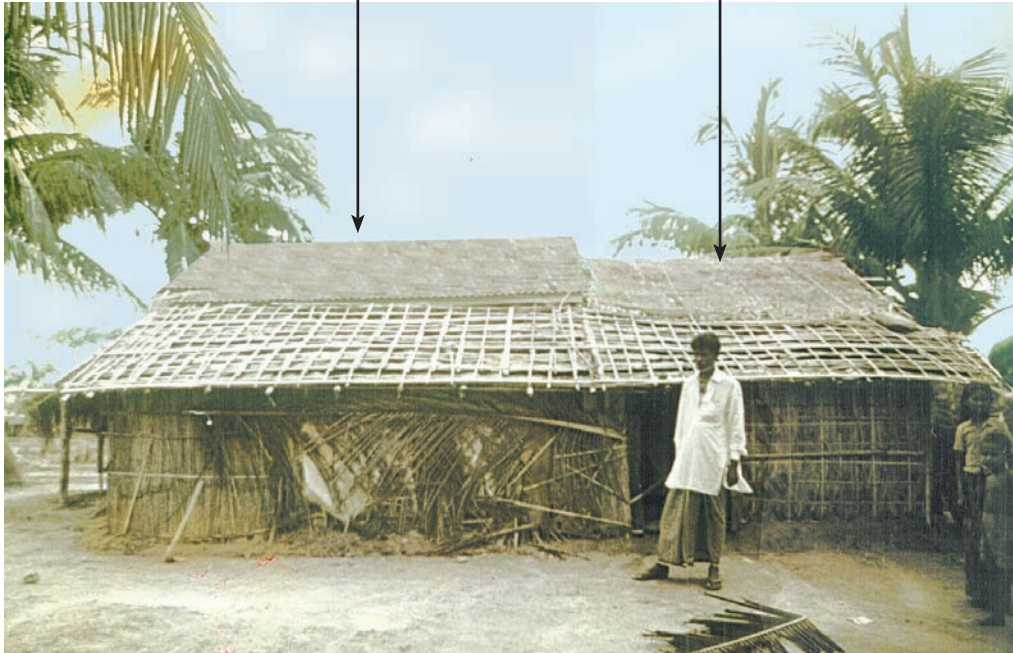
Thatch roof added later

TRANSFORMATION OF THE WIND RESISTANT HUT

Steel sections for fabrication of truss in marine weather require application of properly specified undercoat and regular maintenance. Fabricated steel sections as building materials are inherently more complicated for repair and maintenance, particularly in a low technology area, where people depend on local expertise and locally available materials.

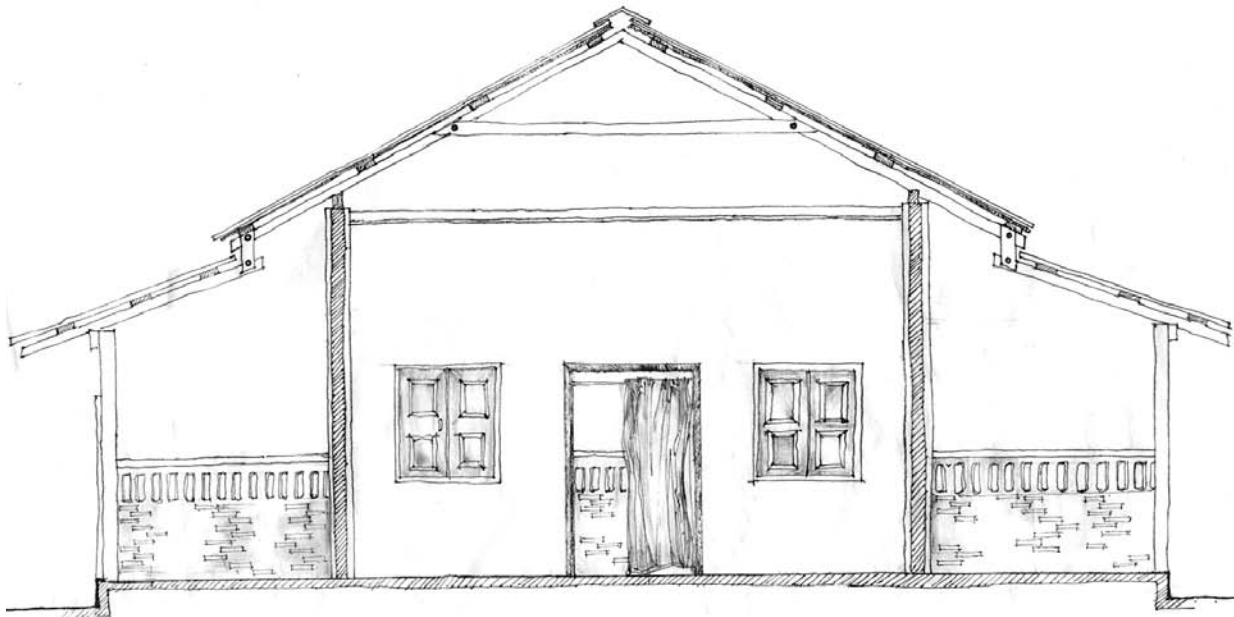
TRANSVERSE SECTION

It has been observed in the cyclone affected areas that there is less likelihood of a house being damaged or destroyed if the roof structure of the house is strong and secured to the vertical support system which is firmly anchored to the foundation.

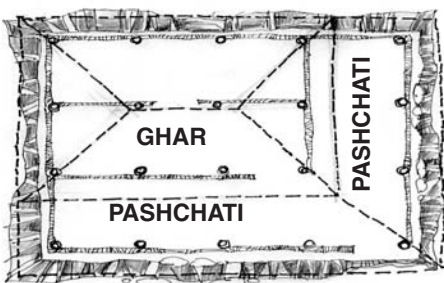
The best plan shape is a square or a rectangle for wind resistance. The traditional houses in these areas are mostly rectangular with length and width ratio within 2:1. It may be mentioned here that length to width ratio up to 3:1 is recommended for cyclone resistant houses.

PLAN :
HOUSE HAVING PASHCHATI ON 2-SIDES

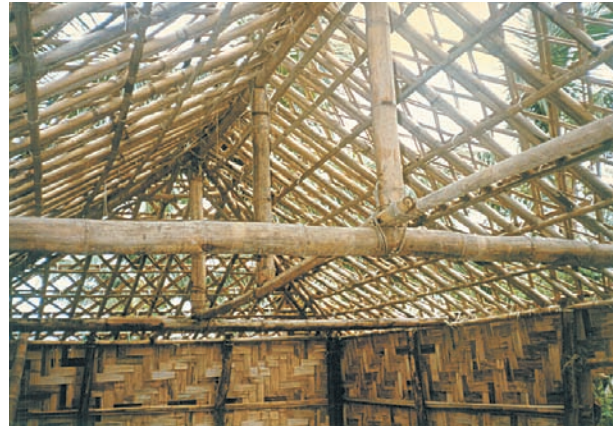
BAMBOO ROOF STRUCTURE

At present both wood and bamboo are used without treatment by appropriate preservative for protection against decay, insects, fungi, termite attack, marine environment and when these materials are in contact with moist ground.

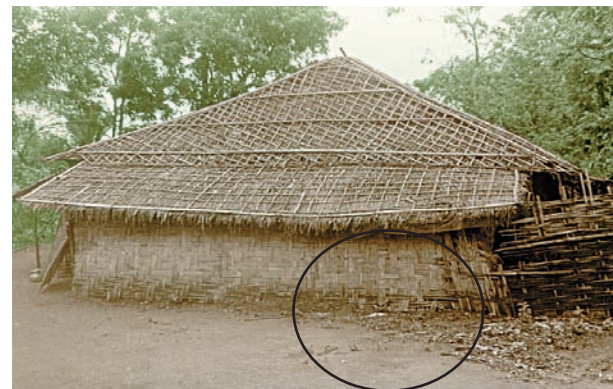
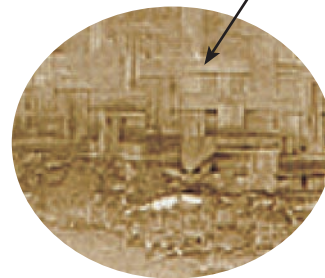
Example of decay

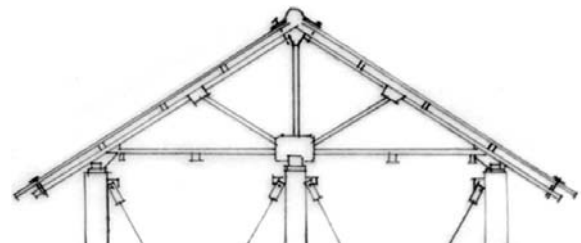
When steel sections are used in marine and salt atmosphere, there is a need for ensuring quality control of materials, proper surface preparation and one word application of specified undercoats.

STEEL ROOF STRUCTURE

Undercoats should be carefully selected for suitability in marine weather conditions. We are listing the chemical compositions of these undercoats below only as a reference.

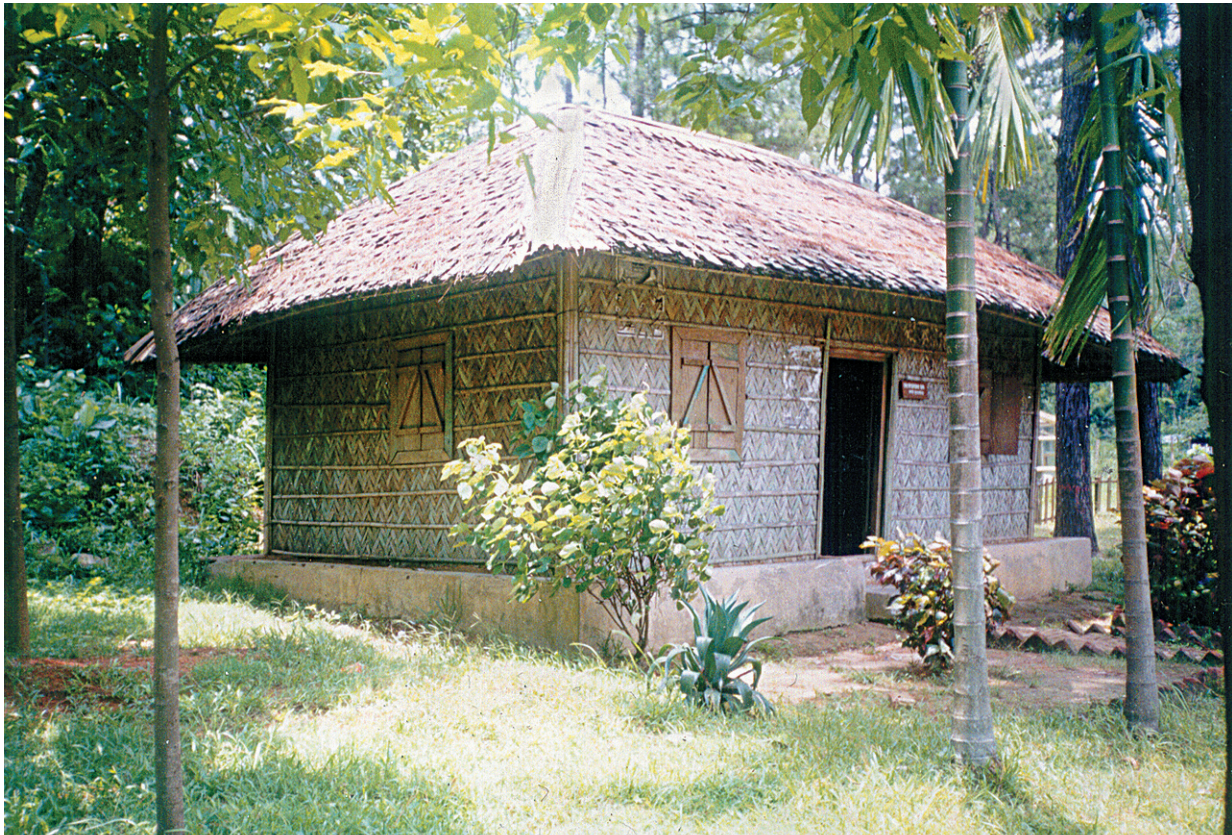
Hut built by BFRI at Chittagong - A pilot project using treated bamboo, wood, Sun-Grass etc.

We interviewed experts in Bangladesh Forest Research Institute (BFRI) and Bangladesh Agricultural Research Council (BARC), and gathered information, booklets etc, on the technology developed by BRFI for preservative treatment. BFRI built a hut using treated bamboo, wood, sun-grass, etc, in 1983. This hut convinced us of the effectiveness of the need and the critical aspect of the preservative treatment. There was no sign of decay or attack by fungi, insects and termites on the building materials of the hut.

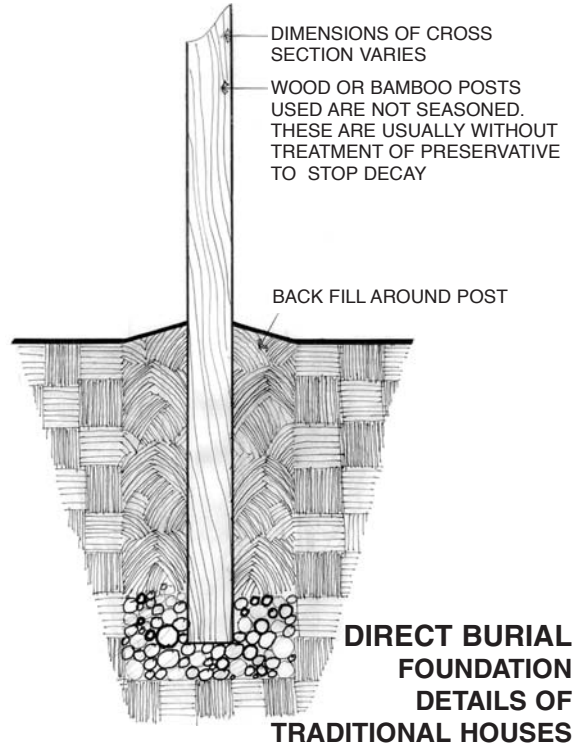
10.6.2 FOUNDATION OF TIMBER AND BAMBOO POSTS

Wood, bamboo and pre-cast concrete posts are used for support of the houses in the areas of our survey and study. The weakest point identified in our survey in the traditional construction methods and techniques is anchorage of vertical supports to foundation system. This weakness is the main reason for strong winds to lift up the entire houses or blow it down. The typical foundation method used in the traditional houses is the direct burial of posts into the soil.

Foundation in accordance with the details in "Typical Footing for Timber or Bamboo Post"

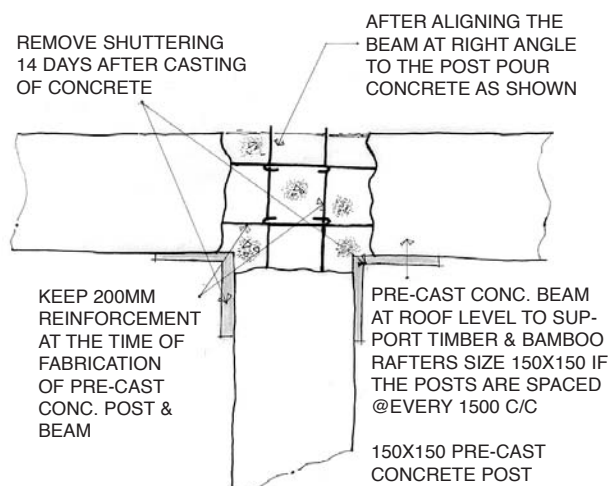
DETAILS OF POST & BEAM

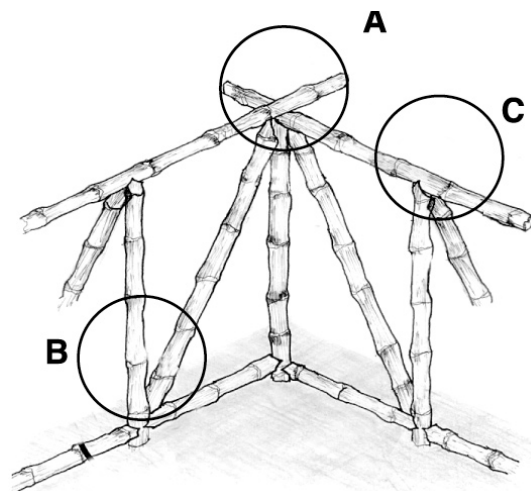
The wind is resisted by woven bamboo or timber board sheathing and vertical support. Diagonal bracing should be used to strengthen the walls, and to reduce the chances of corner failures; due to unequal pressures on two side walls during cyclones.

DETAILS OF CORNER BRACING

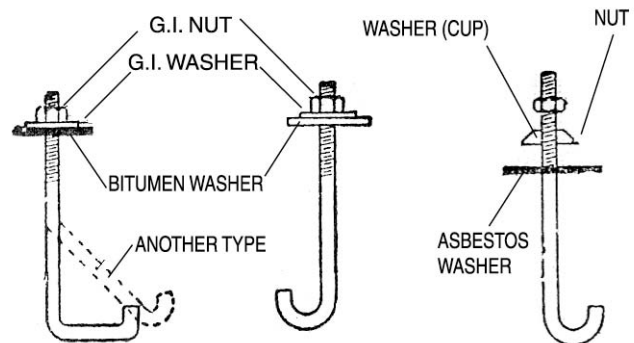
In terms of cyclone resistance we recommend the use of 20 gauge galvanized metal strap, nails, nuts and bolts along with the use of traditional materials like nylon rope etc.

G.I. CRANK BOLT G.I. HOOK BOLT J HOOK

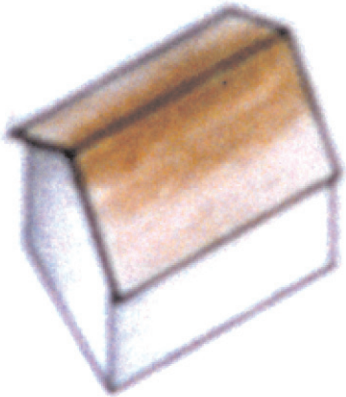
PEOPLE'S PERCEPTION OF THE MAGNITUDE OF WIND LOADING AND WIND DAMAGE ON DIFFERENT ROOF SHAPES

High Gable Roof	
Wind Resistant	Suffer Wind Damage

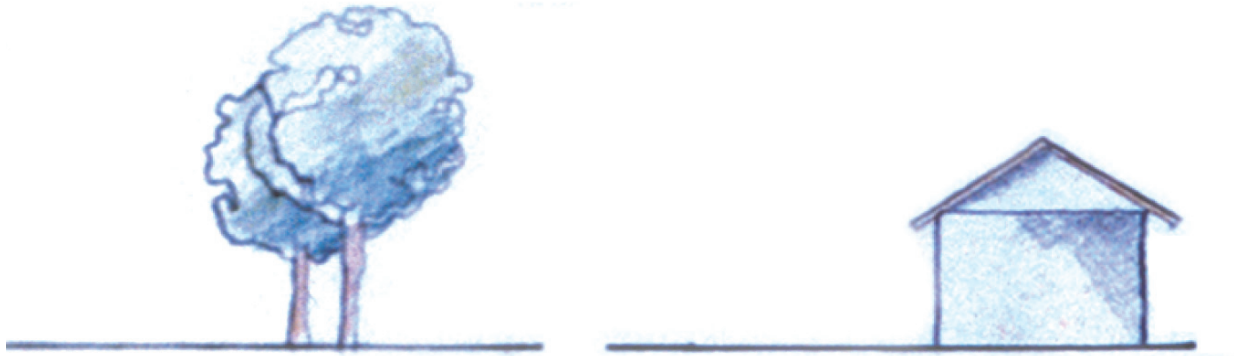
**PEOPLE'S PERCEPTION OF SAFE DISTANCE OF TREES FROM
HOUSES IN THE CYCLONE AFFECTED AREAS**

Safe Distance			
10 Feet	15 Feet	20 Feet	30 Feet
