# **LIBYA SHELTER ASSESSMENT PHASE 1 AND 2**

**SHELTER CLUSTER REPORT**

**01/07/2011 TO 31/12/2011**

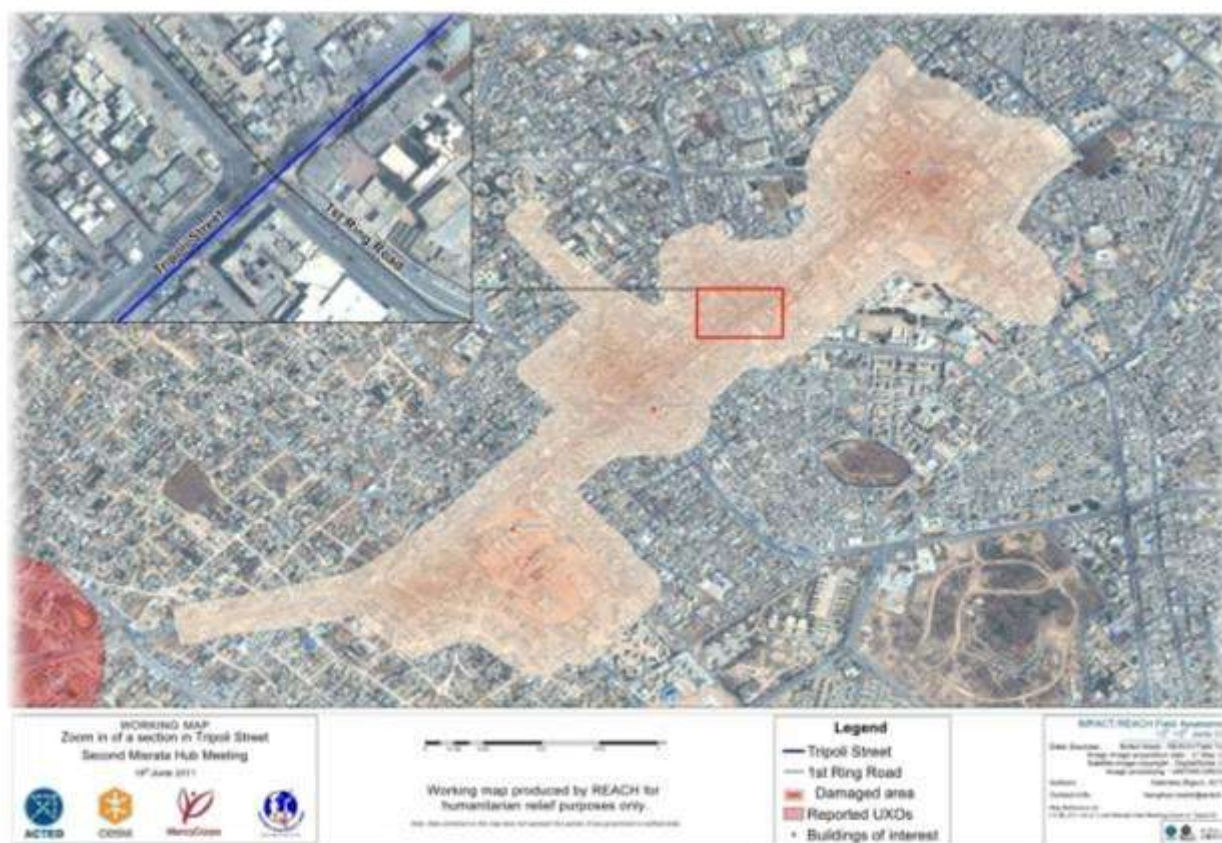
Image 2: Initial Satellite assessment of conflict damages on Tripoli Street, Misrata

The below map provides initial imagery analysis performed on Misrata before ground assessments were conducted. The brown area shows areas of damage caused by the conflict on areas surrounding Tripoli Street, Misrata. Due to the nature of the Libya conflict, with much of the damage caused by horizontal projectiles onto concrete structures, such imagery analysis had constraints as much of the damage could not be viewed from above
