**LANKIEN TOWN
NYIROR COUNTY
JONGLEI STATE**

WASH/NFI Assessment REPORT

Activity:	Assessment of the technical condition of water points, hygiene and sanitation situation as well as of IDP and host community WASH & NFI needs in Lankien following the clashes in the neighbouring surrounding.	
Location:	Lankien	N 08.52604° / E 032.06252°
Duration:	31 st January to 3 rd February 2014	
Itinerary:	Juba-Lankien-Juba	
Mission Team / Counterparts:	PAH	Counterparts
	<p>John Paul Mugo Team Leader WASH Tech Assistant Emergency Response Team +211 928 096 783 john.paul.mugo@pah.org.pl</p> <p>Charles Otieno Hygiene and Sanitation Officer +211 927422883 charles.otieno@pah.org.pl</p>	<p>James Lagu WASH Technician Solidarites International +211 954 008 595</p> <p>Warren Jimmy WASH Technician Solidarites International +211 955 118 422</p> <p>Angie Carrascal MSF Lankien +870776310287 lankien-pc@oca.msf.org</p> <p>Joseph Boyak Executive Director (Acting Commissioner)</p> <p>Peter Gatkuth Kong County Coordinator</p> <p>Wor Biel RRC Coordinator</p> <p>James Chat Deputy RRC</p> <p>Tap Lual</p>

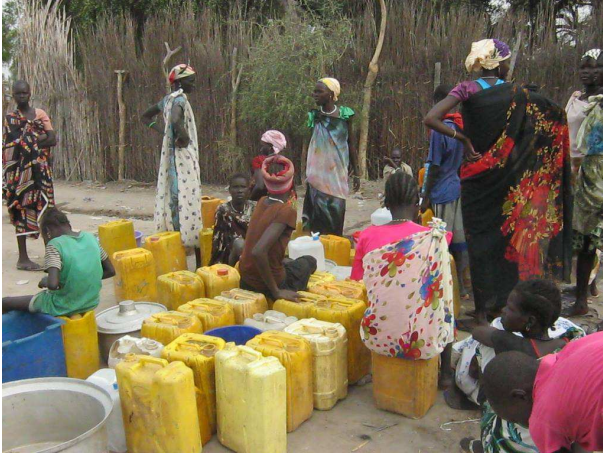
Image 1: Women queuing outside MSF compound to fetch water

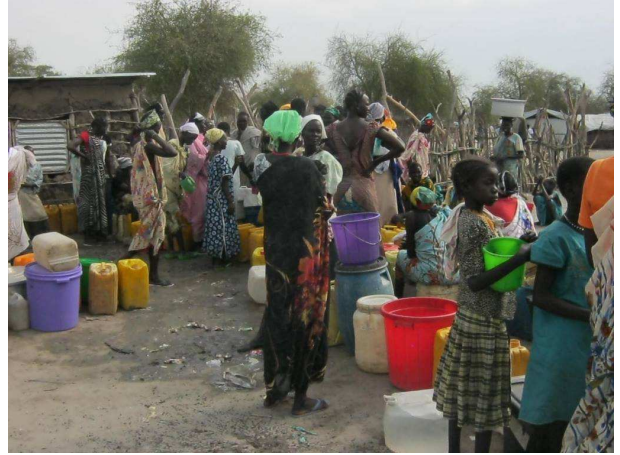
Image 2: The long queues at the tap stands of the water yard at the town center

3. Currently MSF has given their emergency generator to the community to be able to operate the submersible pump which provides water at two separate stations. The community generator had been broken since early 2013 and it is not certain what spares need to be acquired. The MoPI representative also raised issues of sustainability since it requires fuel. It had been inspected by different technicians and no one knows exactly what is the problem. The water yard has a tank which has a capacity of 40m³ is the main source of water for the town. MSF still requires their generator for their clinic and have therefore just given the community three months with the generator while they will provide fuel for the first month only, since they are already overstretched with responding to all the medical needs of the area.

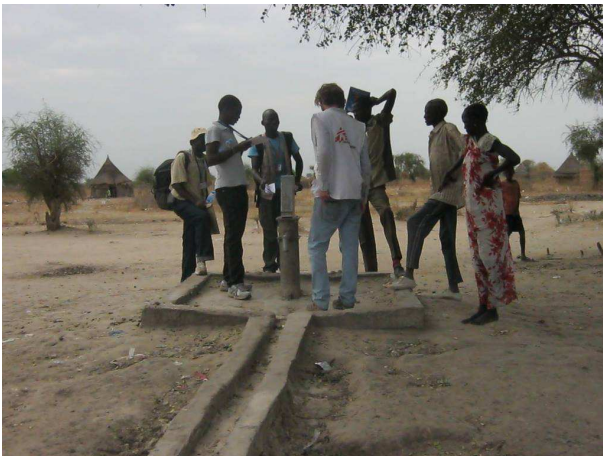
Image 3: The technical team assessing one of the broken borehole

4. In addition, MSF is supplying water via two taps outside their compound; 10m³/day is served.
5. The team which was joined by MSF TechLog team went for a rigorous technical assessment on all the existing boreholes around Lankien centre. The following is a summary of all the boreholes which can be currently repaired;

Water Point (WP)	Status/Recommendation	GPS Coordinates	Beneficiaries using WP
Water System	Working but Needs upgrading to use solar power, currently the system has a submersible pump.	N 08.52678° E 032.05943°	All town centre approx. 27,000 individuals
Borehole 1 IM II	Broken, suspected chain/rod disconnection	N 08.52239° E 032.06347°	School+500 HHs + 1500 IDPs
Borehole 2 IM II	Broken, chain/rod disconnection	N 08.52159 ° E 032.06041°	250 HHs
Borehole 3 IM II	Broken, Cylinder problem	N 08.52336° E 032.05638°	500 HHs
Borehole 4 IM II	Broken, Cylinder and Fishing needed	N 08.52874° E 032.06276°	450 HHs

In addition all the borehole platforms in the area require major rehabilitation of platforms since they are in dilapidated state.

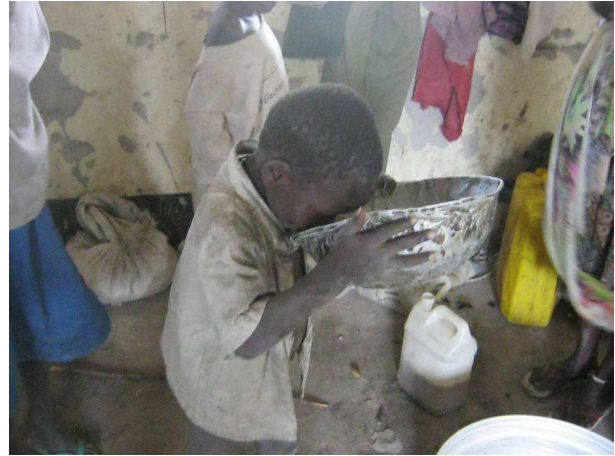
Image 6: A young child drinks water from the unclean container. In the background the 5 litre bottle contains water fetched from the stagnant pool

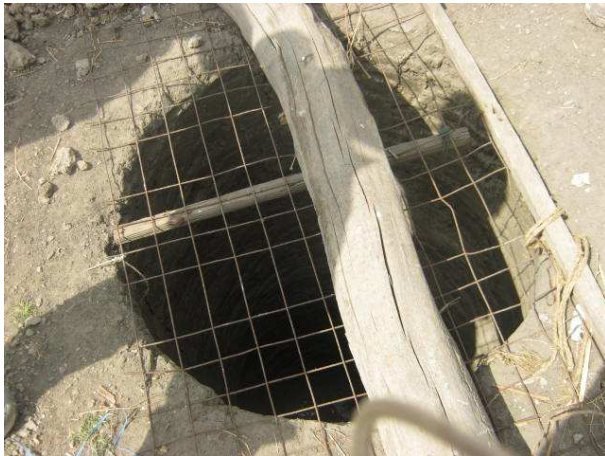
Image 7: An example of a 4m deep latrine which has been dug by the household by their own initiative. However the HH lacks.

1. CLTS triggering in the area, since there are already willing households who can dig and construct their own latrines but they lack the digging tools and the plastic slabs.

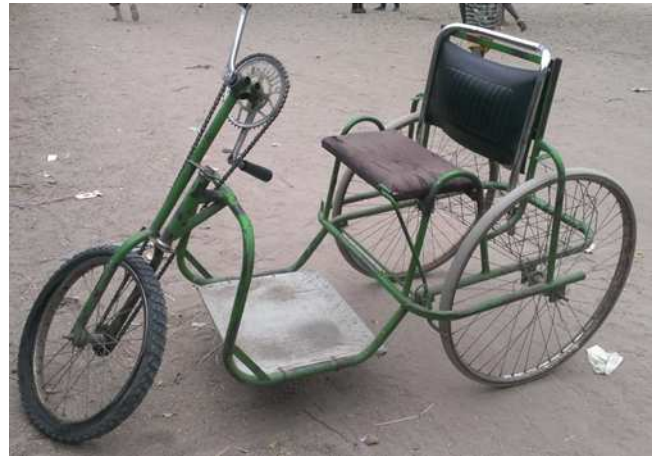
7. There is a disabled resident of Lankien who approached the team and requested for his wheelchair to be repaired or for support of a new wheel and repair items because his current wheel chair has the front tires damaged and it has made it difficult for him to move around the market. The residents name is David Magang and has three children, one wife and is 34 years old. (*see Annex 1*)

Image 8: Showing the status of the wheelchair belonging to David Magang 34 years father of 3 children who is requesting for assistance to repair his wheelchair (tricycle).
