Photo 6 On-the-job training of local artisans is an important aspect of the project

Photo 7 The safe haven complete with toilets and kitchen.

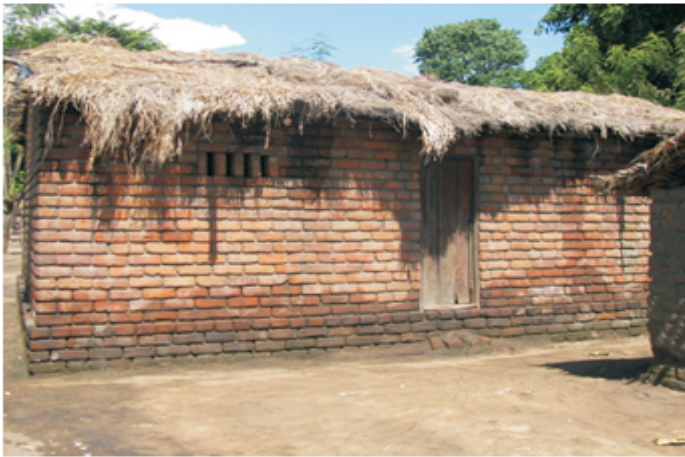
Photo 1 Rising and flowing water causing dampness and weakening foundations

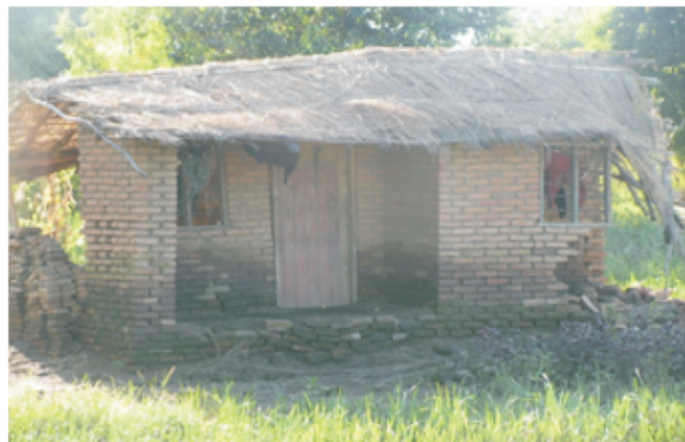
Photo 2 In extreme cases the stability of the house is compromised

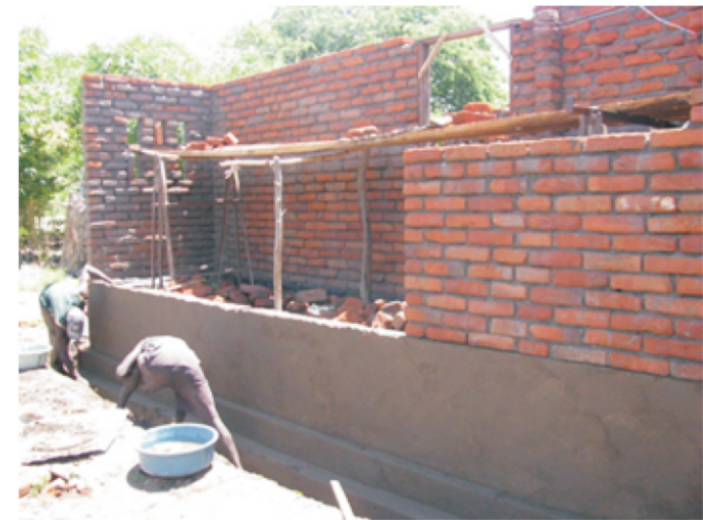
Photo 4 Good foundation construction is the basis of a sound house

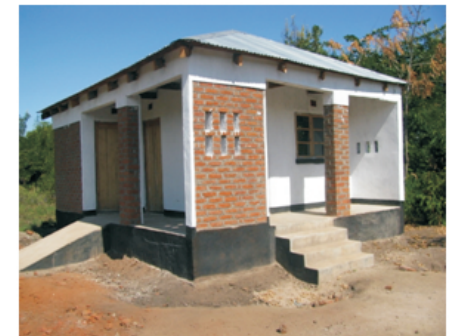
Photo 5 The raised foundation, ring beam and heaped roof are important aspects of sound house construction
