# **A People's Guide to Building Damages and Disaster Safe Construction**

2006

**UNNATI - Organisation for Development Education**

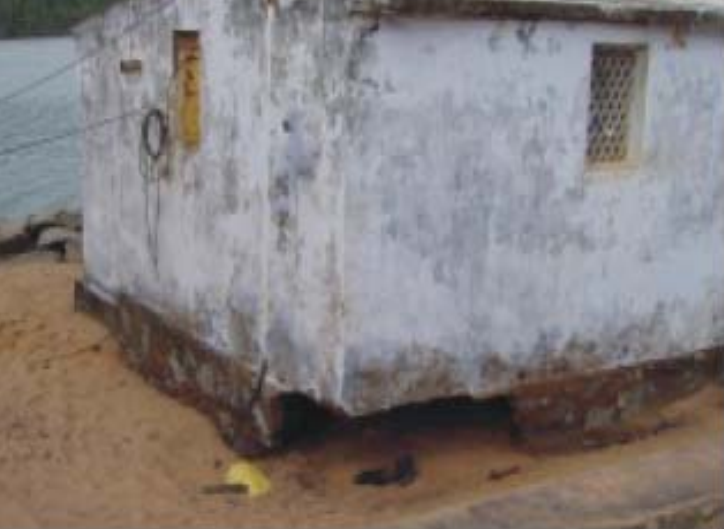
# 1.1

Foundation is collapsed mostly in the corners. In some cases the collapse of foundation has also led to damage to the superstructure.

This damage occurs primarily when storm surge or tsunami strikes. It can also happen in the areas of excessive flooding. It is primarily due to washing away of the soil on which foundations rest and is generally known as **scouring**. The loss of the base of the foundations results in its collapse and if it is beyond a certain extent even the superstructure may get collapsed.

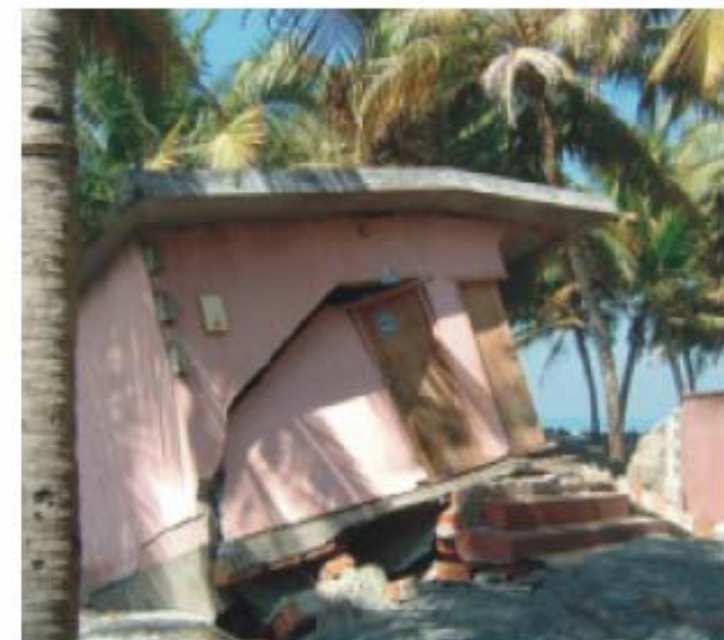
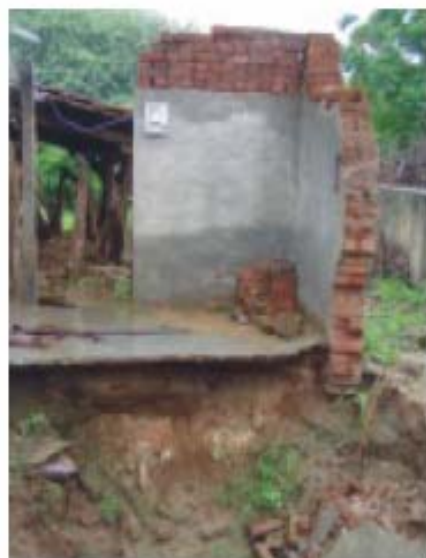
The flowing water washes the soil particularly at the corners because of local whirling action when it strikes the building. But it can also happen even along the length of the wall when the soil is loose and water inundates and then drains taking the soil along with it.

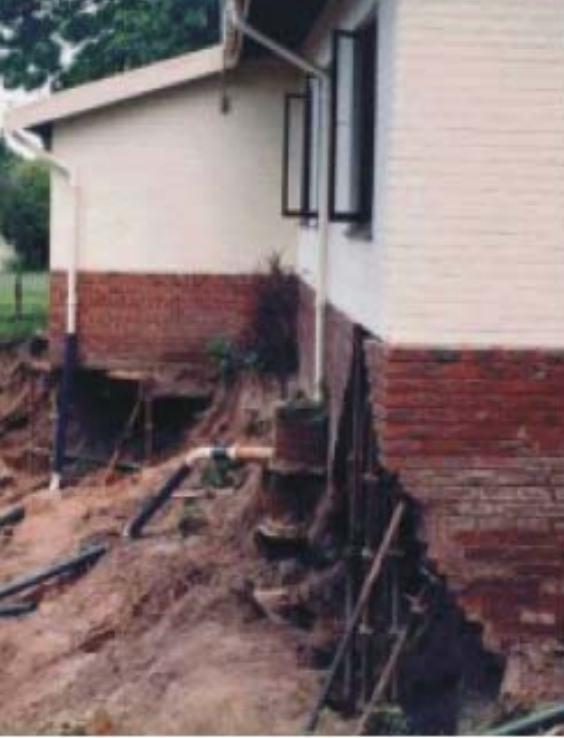
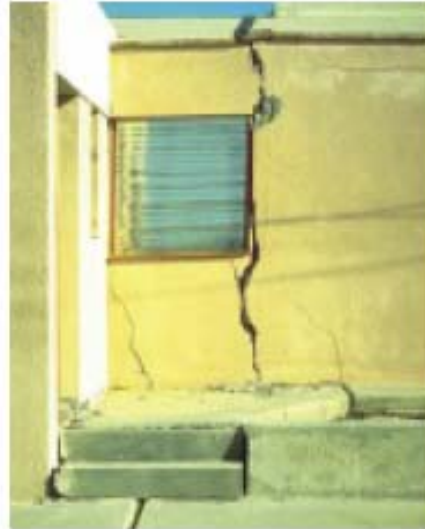
## 1.2

In earthquake affected areas, sometimes foundations get damaged. The foundations develop cracks or even fully collapse at times. In one of the adjacent photographs, we can see the whole building block has tilted and sunk in the ground.

This type of damage occurs primarily in earthquake hit areas. Certain saturated soils may behave like liquids during the earthquake. When soils behave like liquids, they lose their bearing capacity. This phenomenon is called **liquefaction**. In one adjacent photograph, we can see the soil below is lost due to liquefaction and hence the foundations have collapsed. In the other photograph the whole building block has tilted due to sinking of the foundation in soil due to its liquid behaviour.

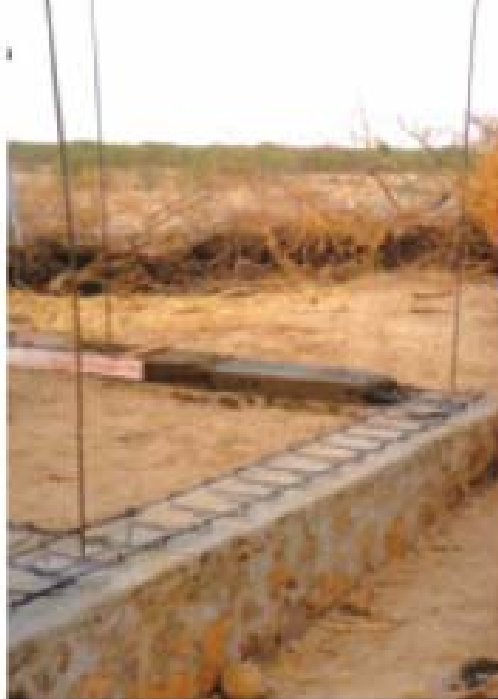
Plinth band should be provided at the floor level. This helps in holding the plinth together and prevents any cracks due to any uneven settlement in the walls above. The photograph here shows installation of plinth band.

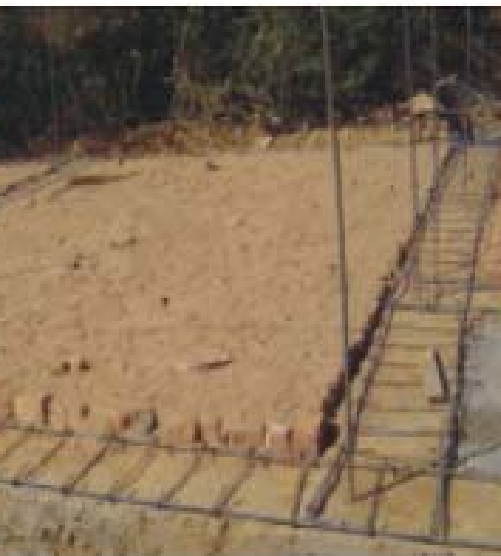
The vertical bar at the corners should tie grade beam and the plinth band as shown in the diagram below and continue upwards till roof.

1. Leveling concrete
2. Vertical bar
3. Tripod

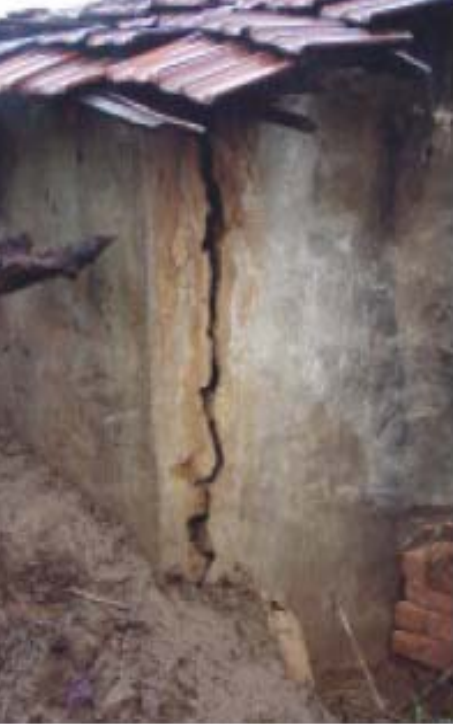
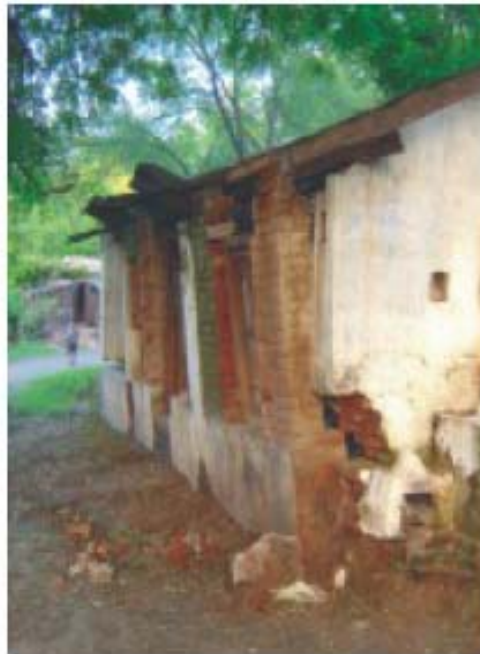
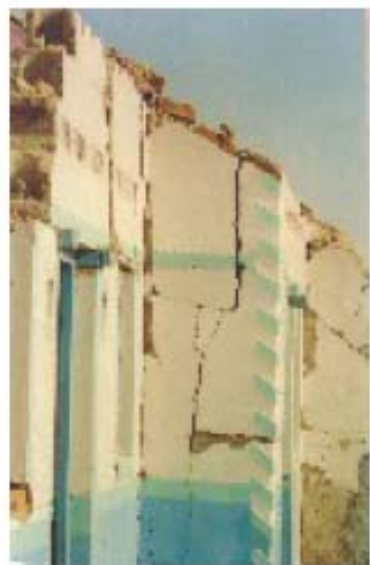
## 2.1

The photographs here show a typical damage of walls that occurs during many disasters. The walls tend to separate at the corners and develop a vertical crack. Some times one of the walls tilts and goes out of plumb.

This is primarily due to insufficient bonding between two walls. In case of earthquakes, due to shaking of both the walls, they tend to separate from each other. Similarly, in floods or tsunami or storm surges, if there is any damage to soil below foundation that can cause tilting of the walls, the walls tend to separate at the corners.

A good bond between two walls would have prevented development of such a crack. Earthquake shaking can also lead to tilting of any wall if the bonding at the corner is not sufficient. The joint between two walls becomes weak if there is insufficient overlap between corner blocks or there is lack of mortar between joints.

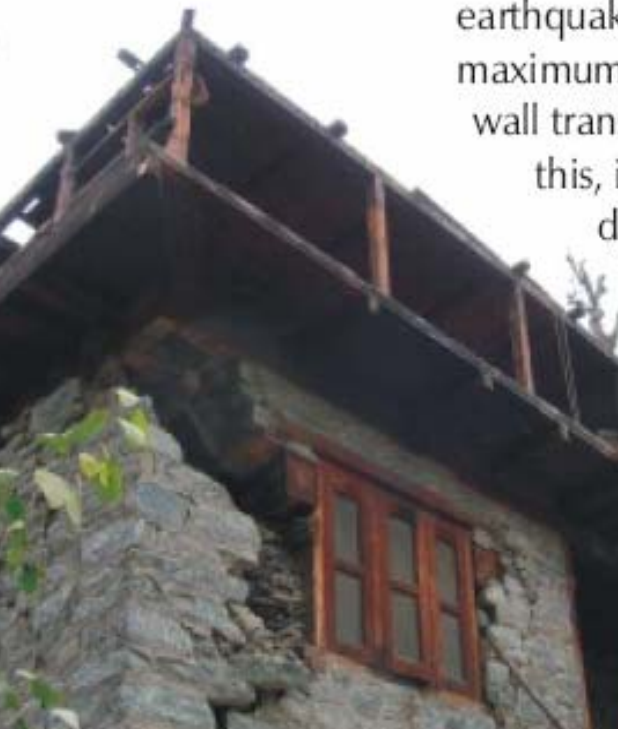
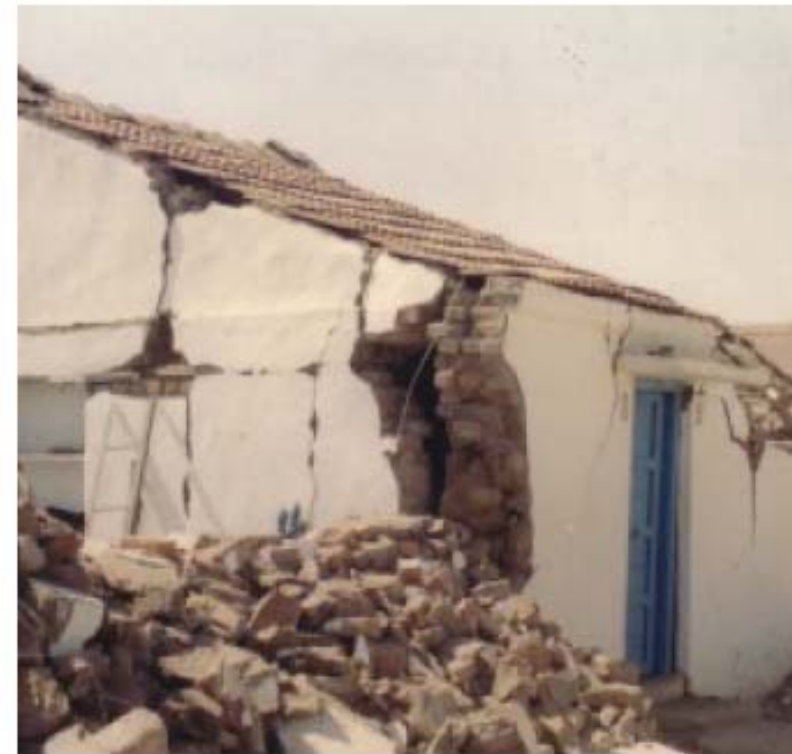
## 2.2

As shown here in the photographs, corners of the walls have collapsed. Though the photographs here show stone masonry but this type of damage can also be seen in the houses constructed with other materials like bricks and concrete blocks.

This type of damage is commonly observed in the earthquake affected houses. During the earthquake, the corners of the building face maximum stress as that's the point where one wall transfers the force to another. As a result of this, if the corners of the buildings are not ductile enough to transfer the thrust, they can fail like in these photographs. As described above if the corner joints between walls are weak due to insufficient overlap of blocks, the corner failures are more probable during the disaster.

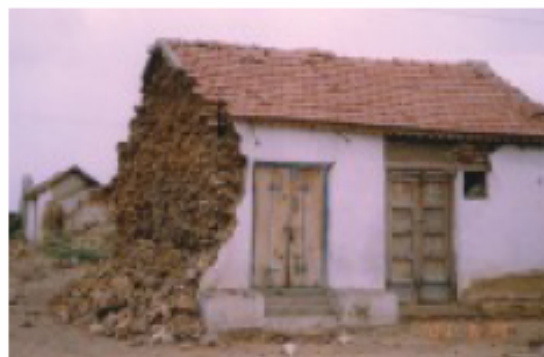
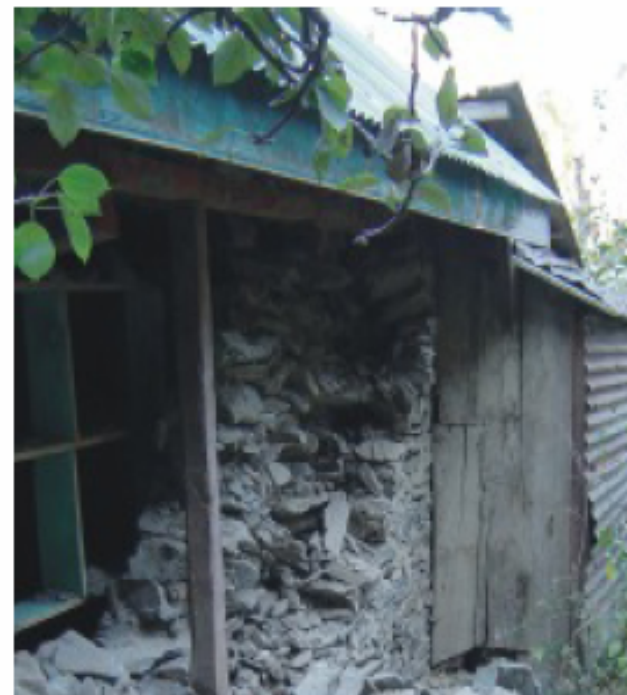
## 2.3

In thick stone walls the inner and outer face of the walls have separated. In the photograph shown here, the separation of faces has led to bulging of the wall from mid height. In other photos the outer face has totally separated and fallen off causing severe damage to the structure.

This type of damage is typical in thick stone walls when such walls face horizontal shaking. As the stones are not properly interlocked, both faces of the walls open up. As the walls are held from the bottom with the foundation and at the top with the roof, **bulging** tends to happen mostly from the mid-height. When two faces completely separate and outer faces collapses, it is called **delamination**. In sloping roof structures where there are gable end walls which are vulnerable to this type of the damage. Delamination can cause collapse of roof due to weakening of the load bearing structure. The walls with such damages can not be repaired and it is the best to rebuild them.

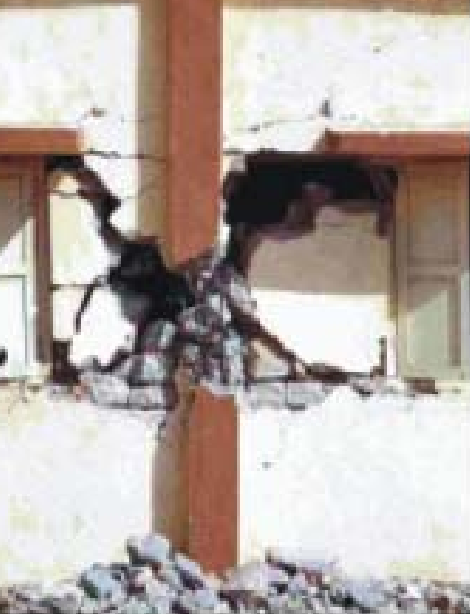
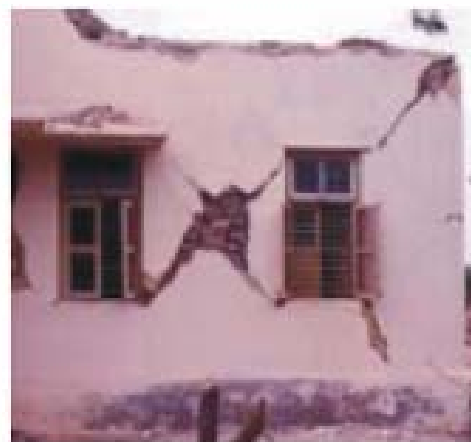
## 2.4

As visible in the photographs, the diagonal cracks develop on the corners of the door and window openings. These corner cracks may develop on both - top and bottom - corners of the window opening.

When the shaking takes place the edges of the opening tend to deform and stresses develop at the corners in diagonal direction. These stresses cause cracks to develop in the walls below and above the openings starting from the corners. Similarly when there are series of openings in a wall. These stresses can cause X shaped cracking in the walls in between the openings. When the lintel above the openings is not sufficiently embedded, these cracks may become more prominent.

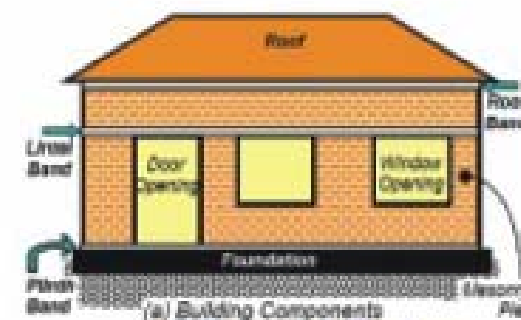
**Earthquake response of masonry building**  
- no vertical reinforcement is provided in walls.

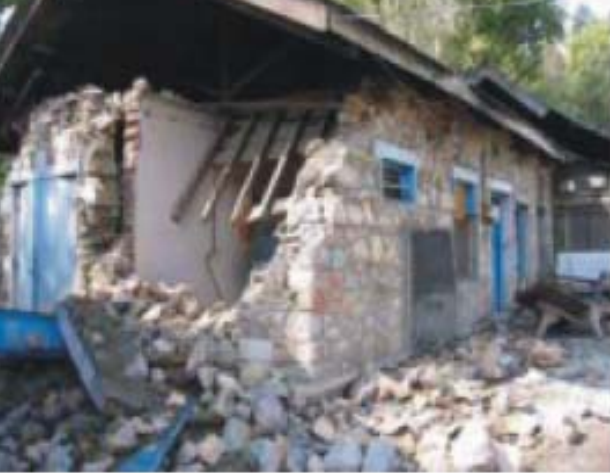
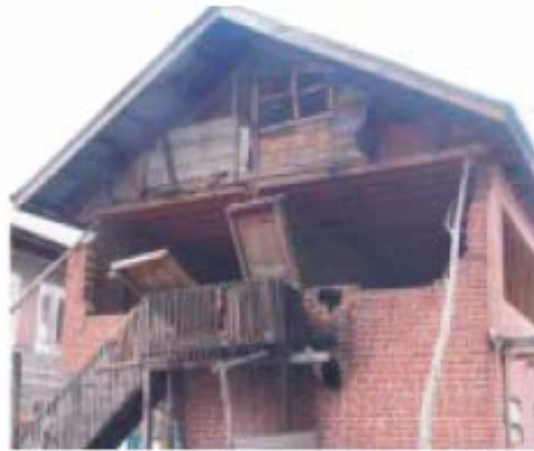
## 2.5 The photographs here depict collapse of the walls. The collapse of walls threatens complete building as the walls are load bearing.

The collapse of walls happens due to various reasons. Where major portion of walls is collapsed, it is due to failure of walls due to shaking in the direction of its thickness. The walls are weaker in this direction. The walls are stronger to resist shaking if it is in the direction of its length. As a result of shaking and lack of cross walls, it can go out of plumb and collapse. The walls with more height are more susceptible to such damages for example gable end walls. Similarly free standing walls such as boundary wall or a parapet can also have **out of plane collapse**.

The walls can also be damaged and collapse when they face horizontal impact, say for example, in case of tsunami. With such high impact, the walls can disintegrate in pieces leading to total collapse of the structure.

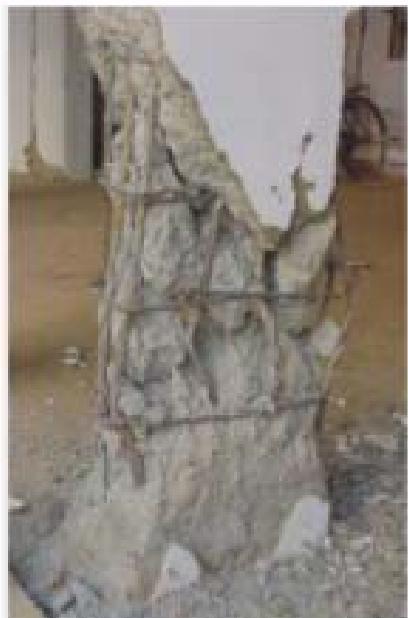
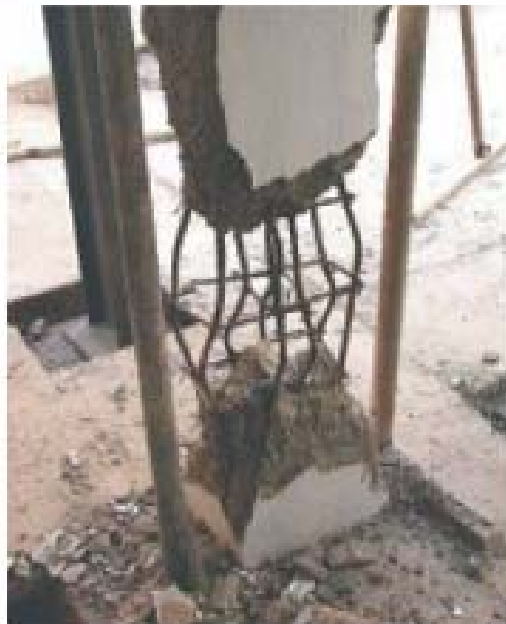
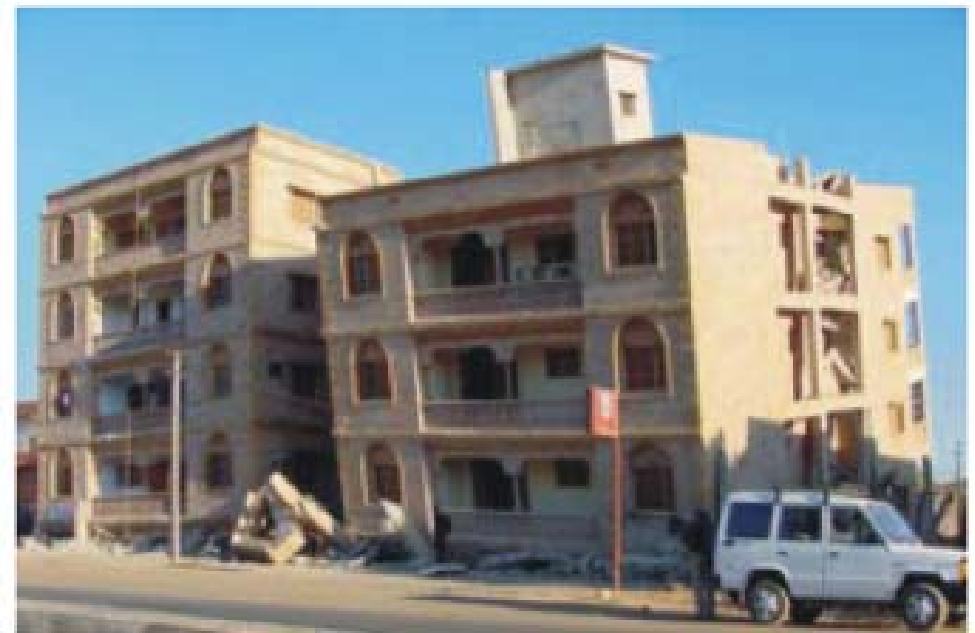
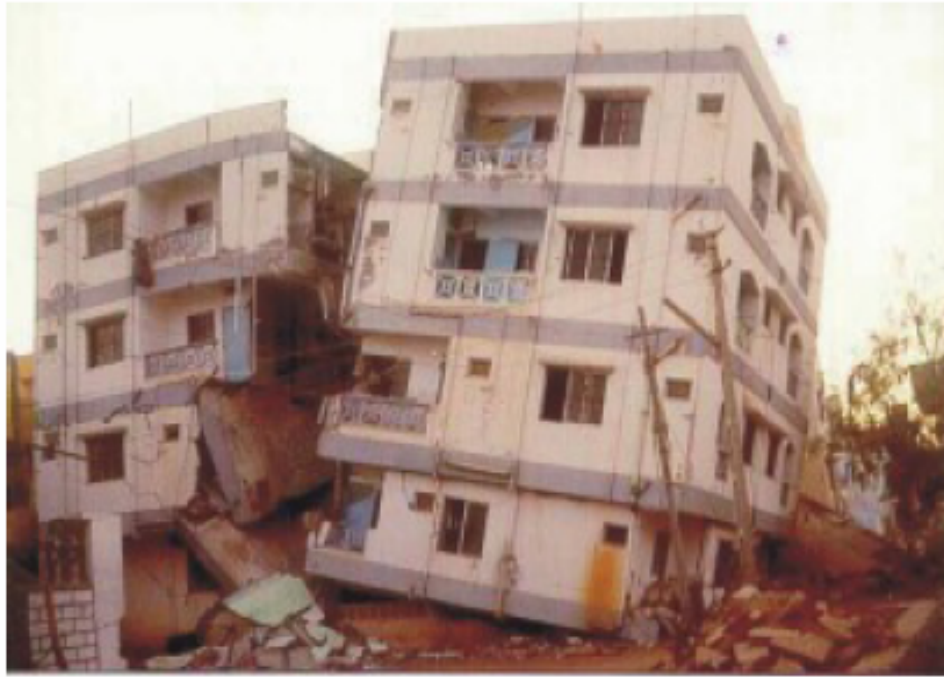
## 2.7

The photographs show that columns of the buildings have been damaged in the earthquake. The reinforcements of the columns have spread outwards and the stirrups holding the vertical reinforcements have failed. Also the concrete part of the columns has been damaged. It is also noticeable that it has occurred at the junction with the beams or the foundation. In other photographs, columned storey has completely collapsed and building has come down.

This type of damage is known as **buckling** of the columns. The buildings that are on the stilts and have a clear storey are particularly vulnerable to such damages. The height of clear storey is very critical. If the columns are too long or too short, they can fail due to the shear forces. As the shear force is the maximum at the junctions of the beam or of the foundation, the failures are more likely to occur there. Inadequate and faulty installation of the stirrups in along the height of the column makes it further weak. The failure of the columns due to shear can result in the complete collapse of clear storey and the whole building can come down as in the photographs.

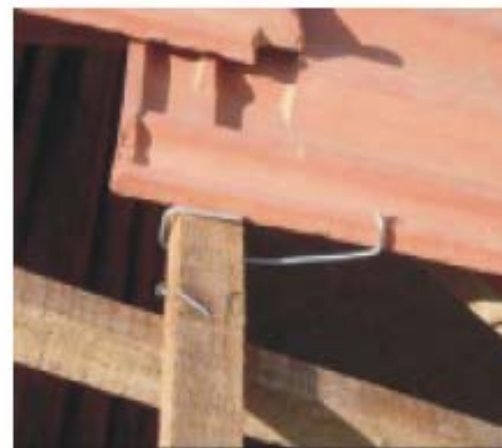
- The roofing components should be anchored with the understructure. The CGI sheets should be fixed using J shaped hooks. And hooks should also be incorporated to hold mangalore pattern tile roofs as shown in the photograph. With this anchorage, the tiles can not fly off.

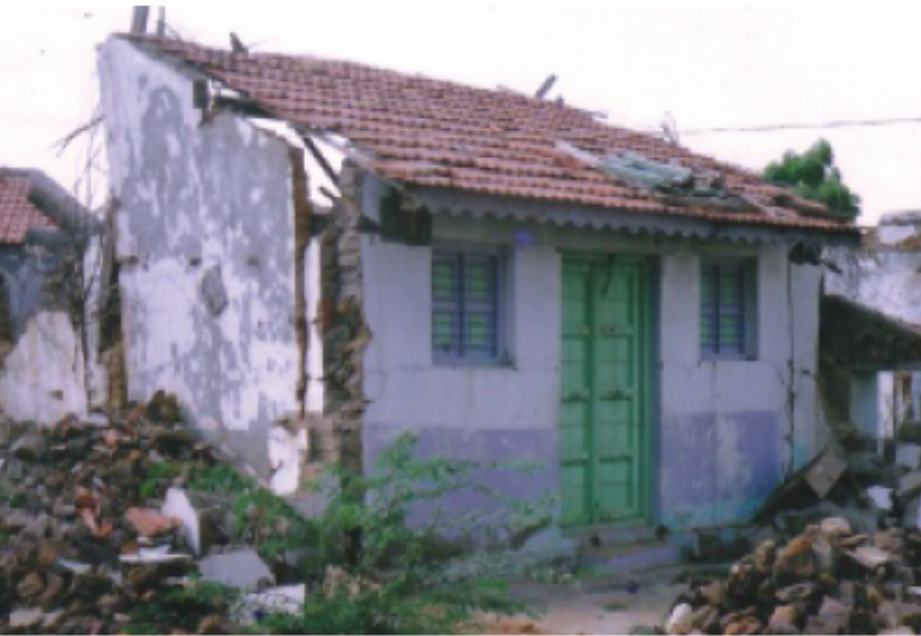
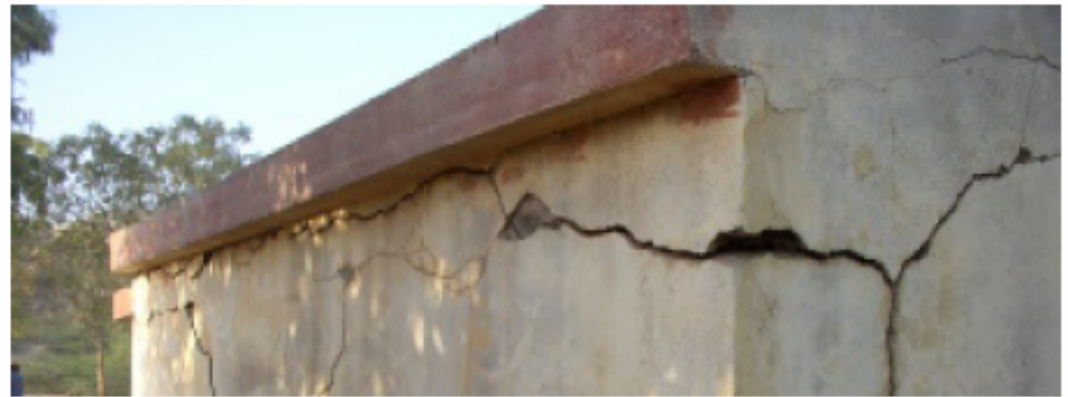
## 3.2

The damage in photograph shows that the sloping roof has dislocated from its position. In the other photograph we see that RCC roof has separated from the walls and a crack has developed all along.

This type of damage occurs due to independent movement of the walls and the roof. When the walls and roof are not properly connected, they tend to separate during the sway. Too much of dislocation with insufficient bearing can also cause collapse.

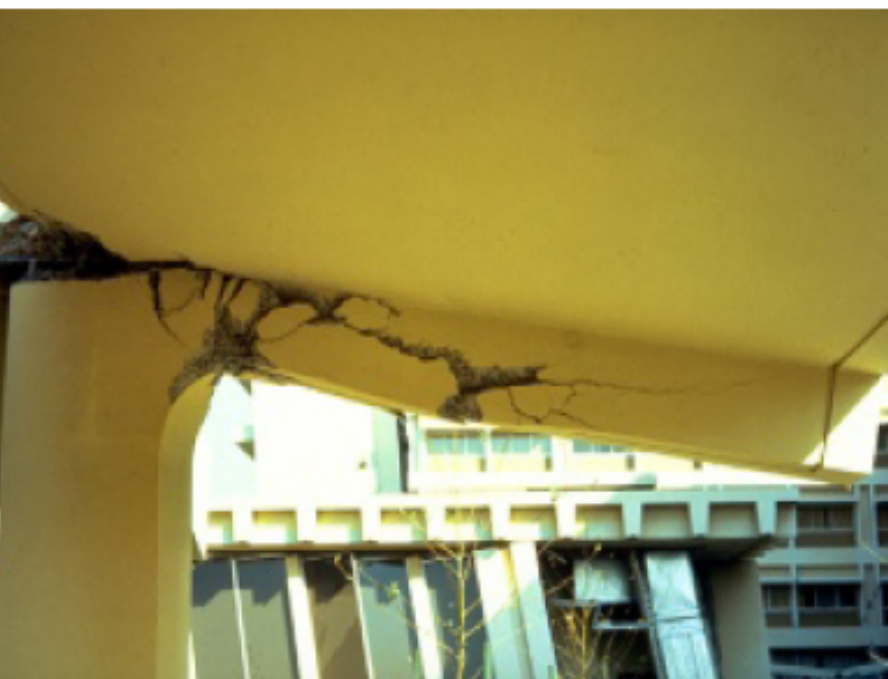
### 3.3

The adjacent photograph shows the damage to a cantilever structure. The cantilever structure can be a verandah roof, balcony, chhajja or window and door shade.

Cantilevers develop stress at the junctions with the walls as a result it is this point where most of the failures occur. Parapet walls also behave like a cantilever during the earthquake and therefore can get damaged.
