“GABION BANDS”: A Proposed Technology for Reconstructing Rural Rubble Stone Houses after the 2015 Nepal Earthquakes

By Randolph Langenbach, 27 August, 2015, updated 10 September, 2015
www.conservationtech.com & www.traditional-is-modern.net

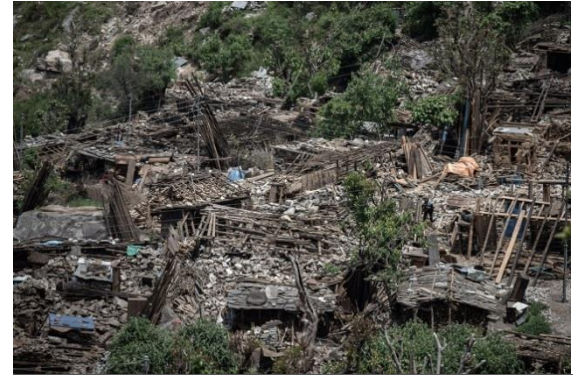
Destroyed rubble stone houses. (web)

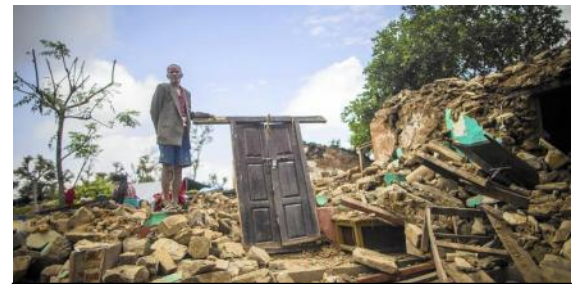
Destroyed house in Gorkha District. (web)

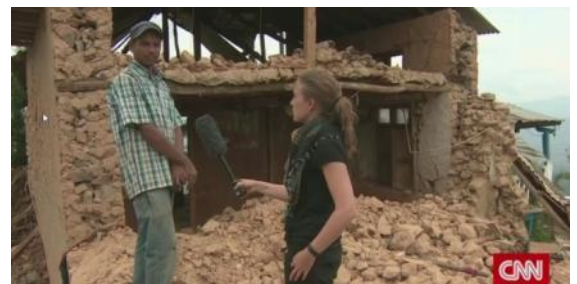
Collapsed house showing horizontally bedded rubble stone construction in Gorkha District. (web)

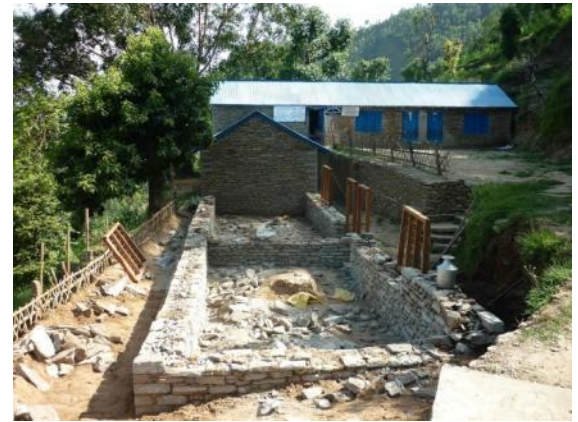
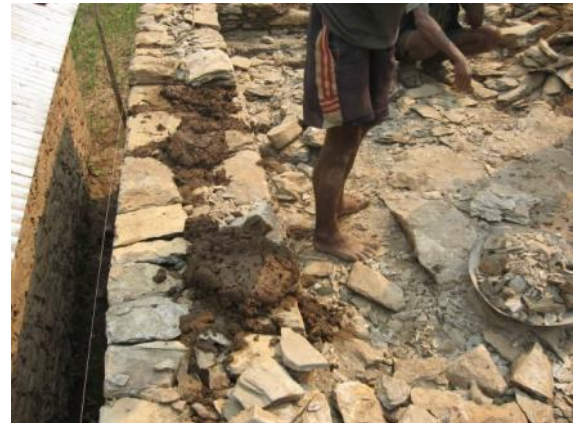
Photos by Prem K. Khatri of school construction in Gorkha district.

The school shown being constructed in photos by Prem K. Khatri shown in the photo on the right is being done with a degree of masonry expertise, and that the walls consist of flat stones that are roughly dressed (the term "dressed" in stone masonry means tooled and shaped so that the stone can be properly bedded in horizontal layers or 'courses'). The mortar is clay without added lime (and thankfully, no Portland cement). The walls appear to have rubble cores between the inside leaf and outside leaf, each of which are one stone thick). Almost all of these rural rubble stone houses completely lack bond courses, as such would result in walls which are not smooth. The roofs are constructed with rafters resting on the walls and a ridge beam that is often not well attached to the stone gables at either end.

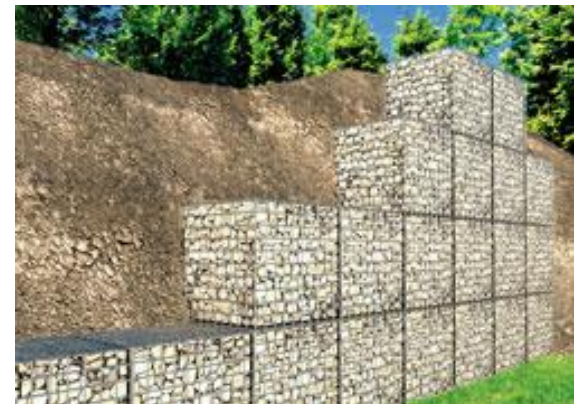
Photos from web of gabion basket retaining wall (above). The photo below shows how inconspicuous the wires can be if the basketing is of only a single layer of stone.

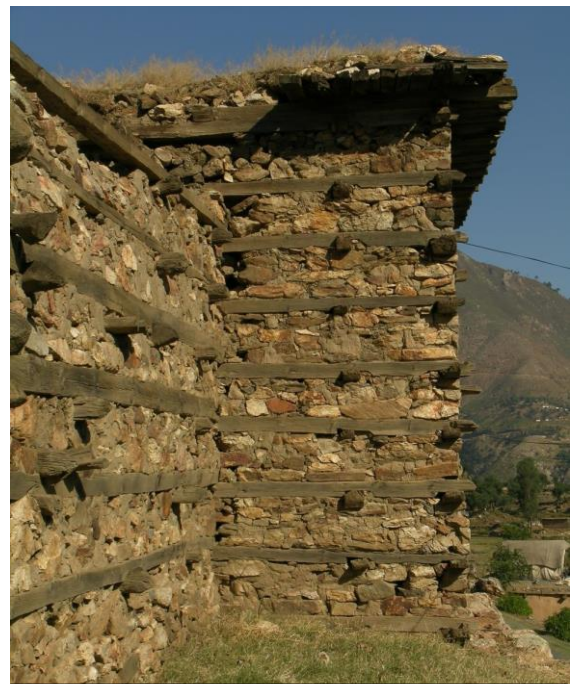
A 19th century timber-laced rubble stone fort in Northern Pakistan near epicenter of 2005 earthquake that killed 89,000 people. It survived with very little damage despite having been abandoned and unmaintained for half a century! (Photo by author)

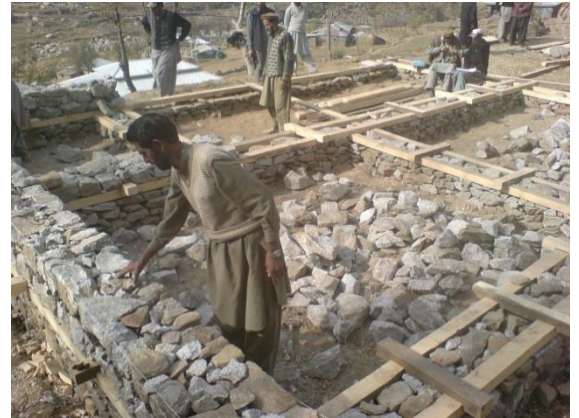
Examples of new building being constructed with timber bands in Pakistan after the 2005 earthquake. The gabion bands proposed here would lay into the wall and overlap in a similar way, as well as secure the wall to the floor diaphragm as seen in the bottom view. (Photos by Tom Schacher)

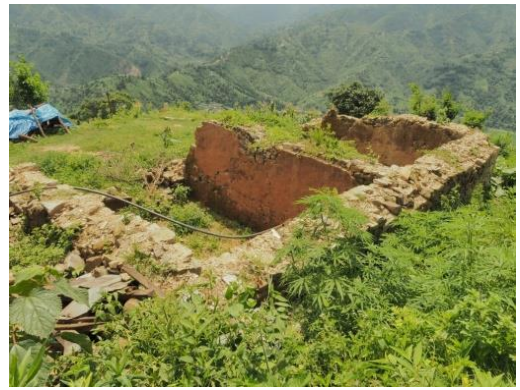
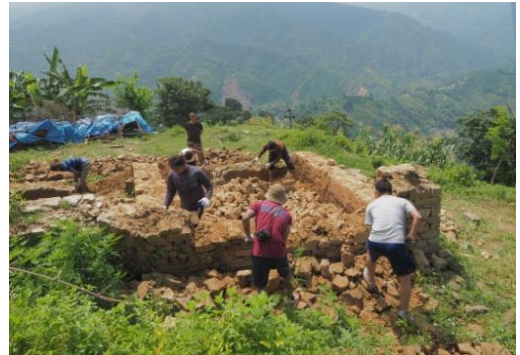
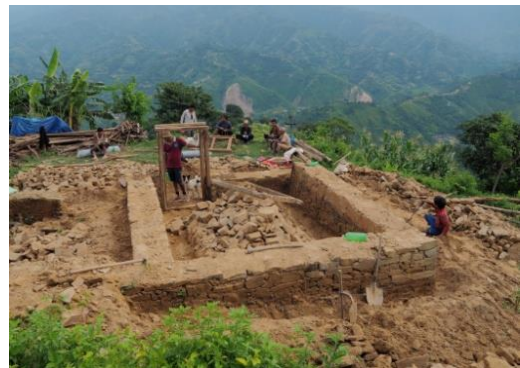
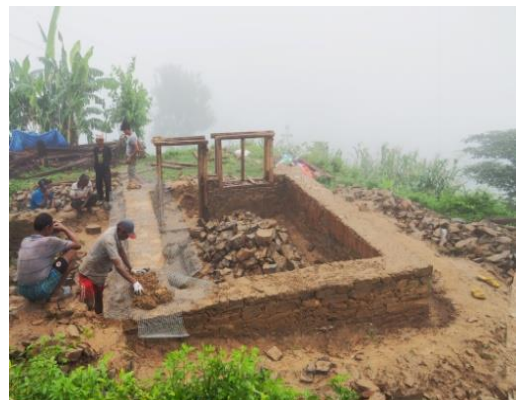
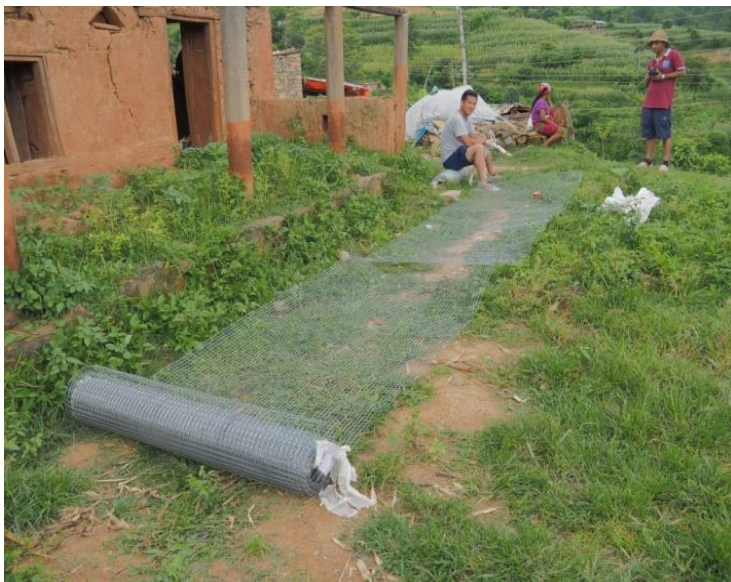
The photographs on the right show the progress of the project from the initial demolition of the ruins to a common height, and the reconstruction of the house with the welded wire-mesh bands (ring beams). Below you can see the laying out and cutting of the wire mesh to size, and then in the 3rd, 4th, and 5th pictures on the right, the laying out and wrapping of the bands is visible. The corners are interlocked by wrapping the ends of the two bands back onto themselves such as both bands form a single ring around the corners of the structure.

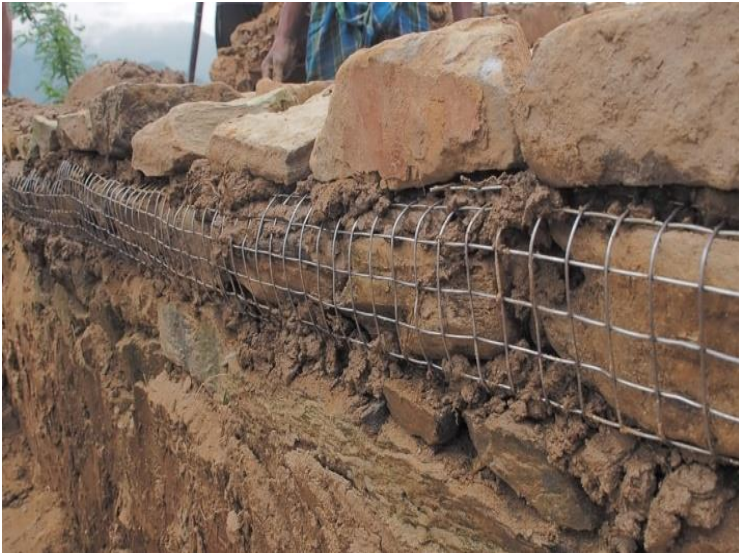
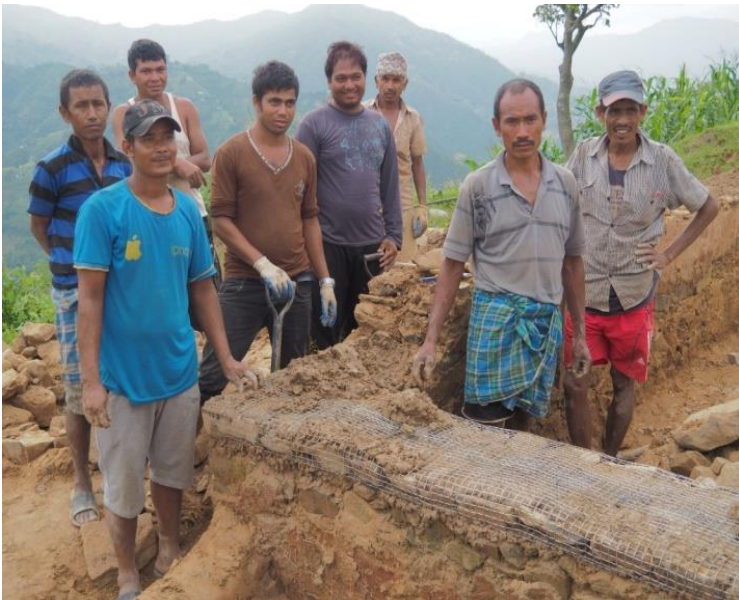
The wrapped band can be seen in the picture below. When the house is completed, this wire band can be plastered with mud plaster. In the photograph below that, the family and team of masons from the community is shown who built the house, which was completed as a shell in just 4 days. The roof is shown as it was placed only temporarily on the structure during the documentary filming, but the intention is to install it permanently on timber rafters, and perhaps in the future to add a second story.

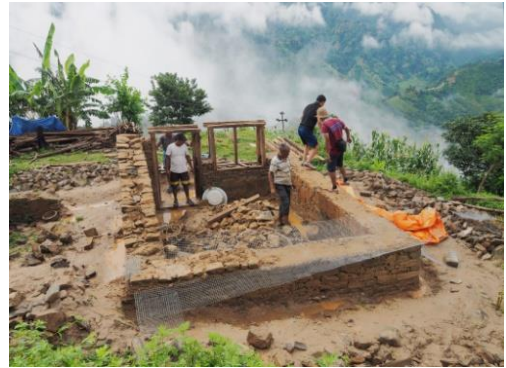
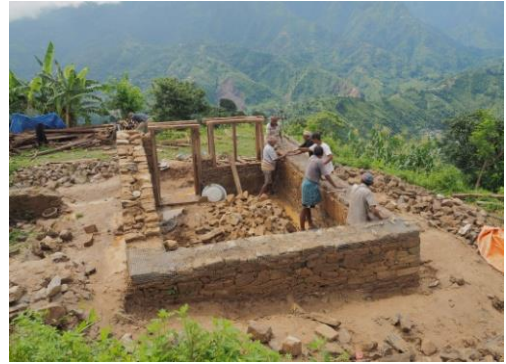
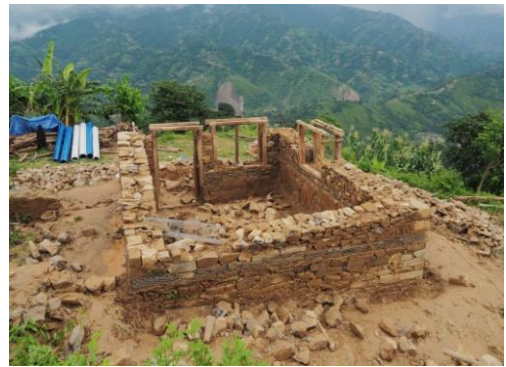
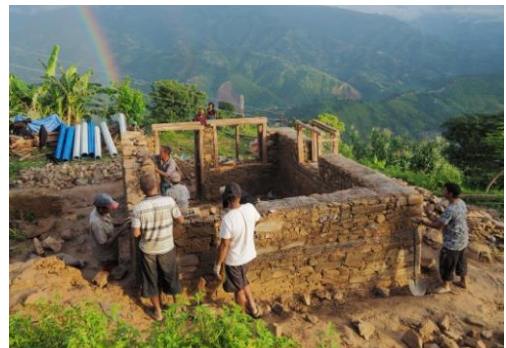
In addition to the installation of the bands, the wire mesh was used to fabricate a beam with stones inside so to span the corner to support a simple chimney, and so to address the usual problem found in many houses where the kitchen stove is an open fire filling the kitchen with smoke.

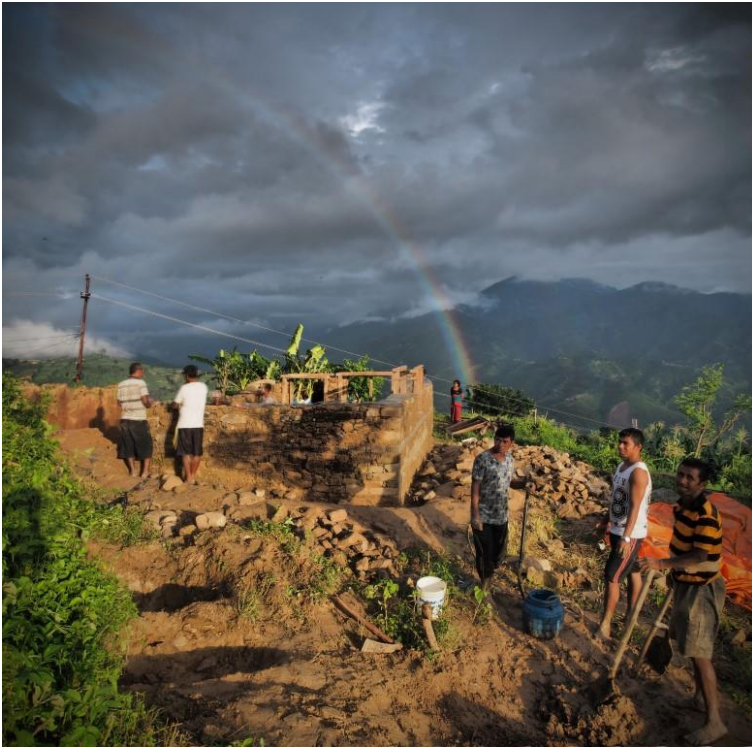
As the walls of the house neared completion, the heavens marked this remarkable project at the moment with a rainbow.

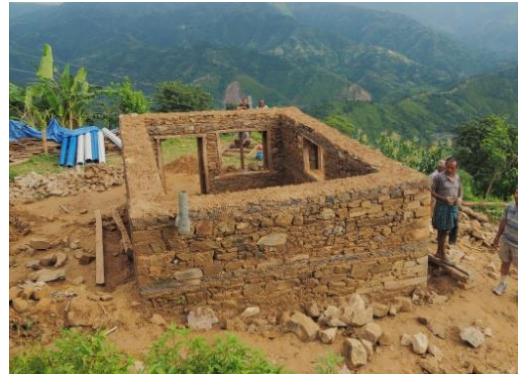
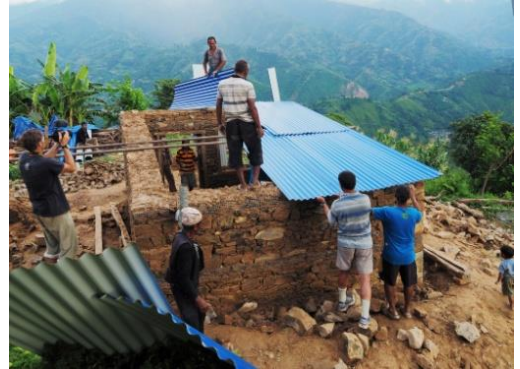
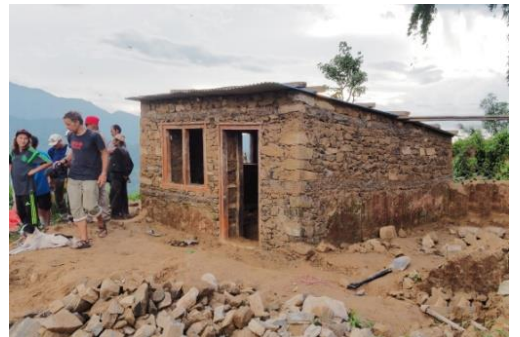
The house shell shown here was built in 4 days. The roof shown is only placed on it temporarily – as the wood framing for the permanent roof is still to be installed. The family also plans to rebuild the 2nd room onto the foundations that are visible to the right.

The cost of the wire consumed in the construction of this one room structure was approximately 15,000 NPR (about \$150 USD)
